Agilent HPLC System Firmware Bulletin

Firmware Set A/B.06.10

1100/1200/1120 LC System

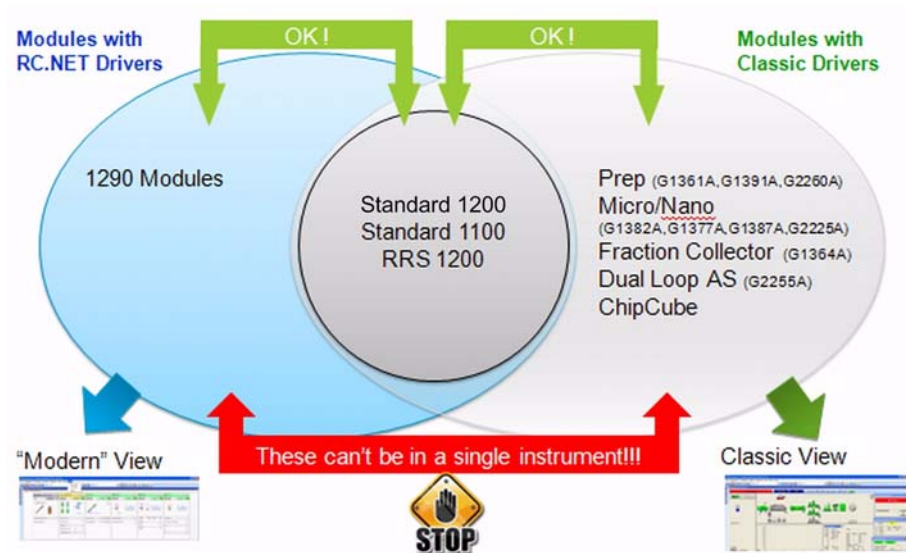
Figure 1 Agilent ChemStation B.04.02 vs. 1290 and 1100/1200 modules

Due to a new driver concept the initial Agilent ChemStation B.04.02 release does not support all combinations of 1290 Infinity LC System with 1100/1200 modules, see [Figure 1](#) on page 92.

For a complete compatibility matrix contact your local Agilent ChemStation Support.
