# Measurement of composite surface contamination using the Agilent 4100 ExoScan FTIR with diffuse reflectance sampling interface

## Application note

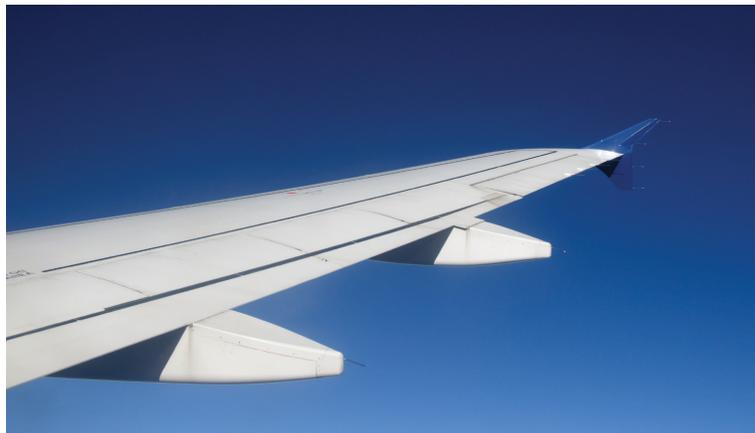
Agilent Technologies  
Danbury, CT, USA

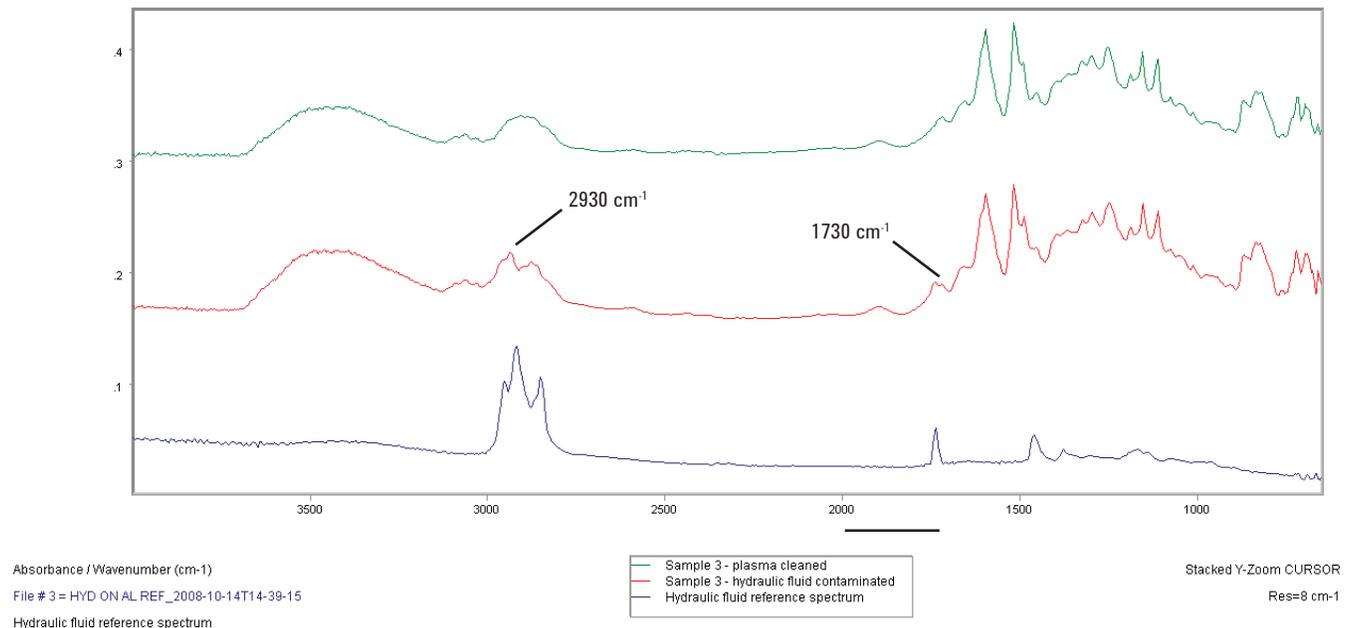
**Figure 3.** FTIR spectra of composite 'Sample 3' contaminated with hydraulic fluid, and cleaned composite, compared to a hydraulic fluid reference spectrum
