Bioanalyzer System

Troubleshooting Section

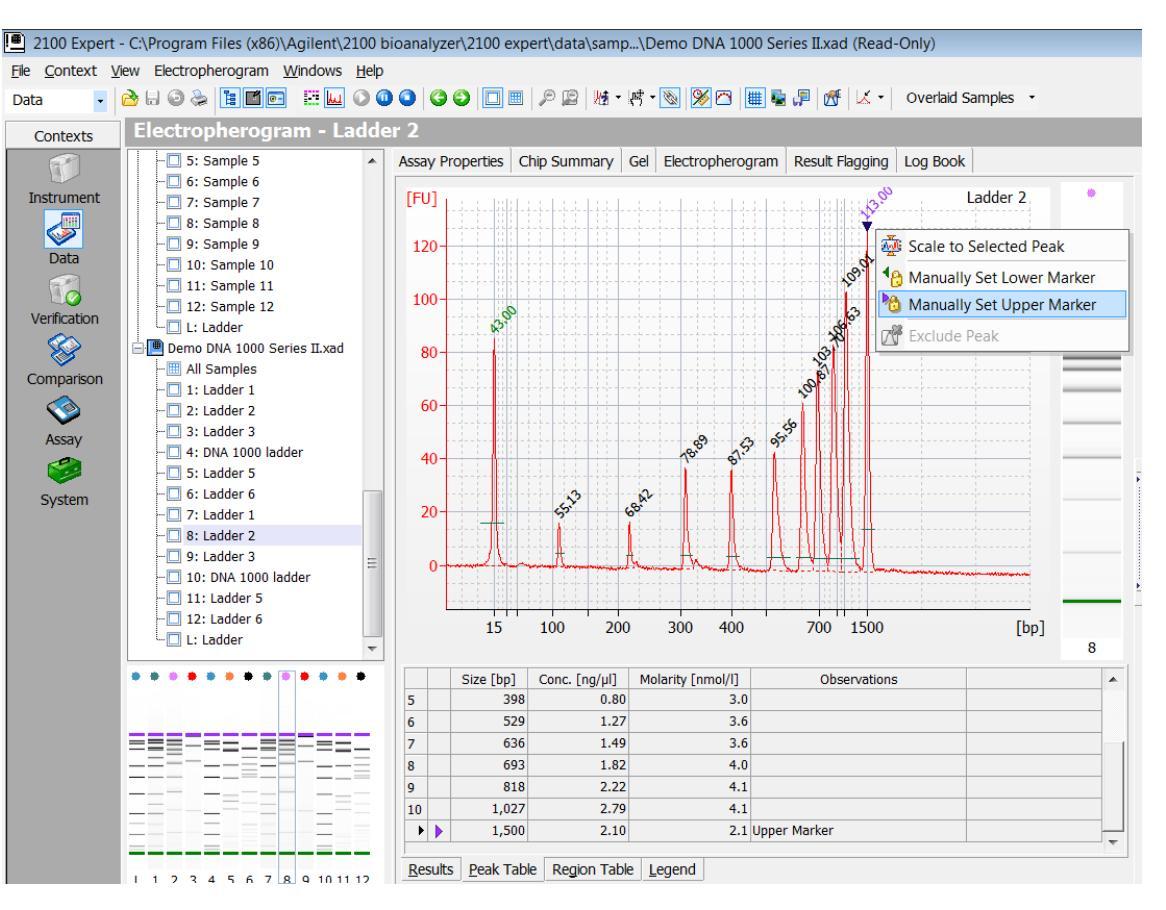
- Manually set Marker(s)
- Get peak recognized as a peak, use Manual Integration
- If one sample is missing its Upper Marker, go to File > Save Selected Sample > choose ladder and all samples except the affected sample. This will salvage the remaining samples.

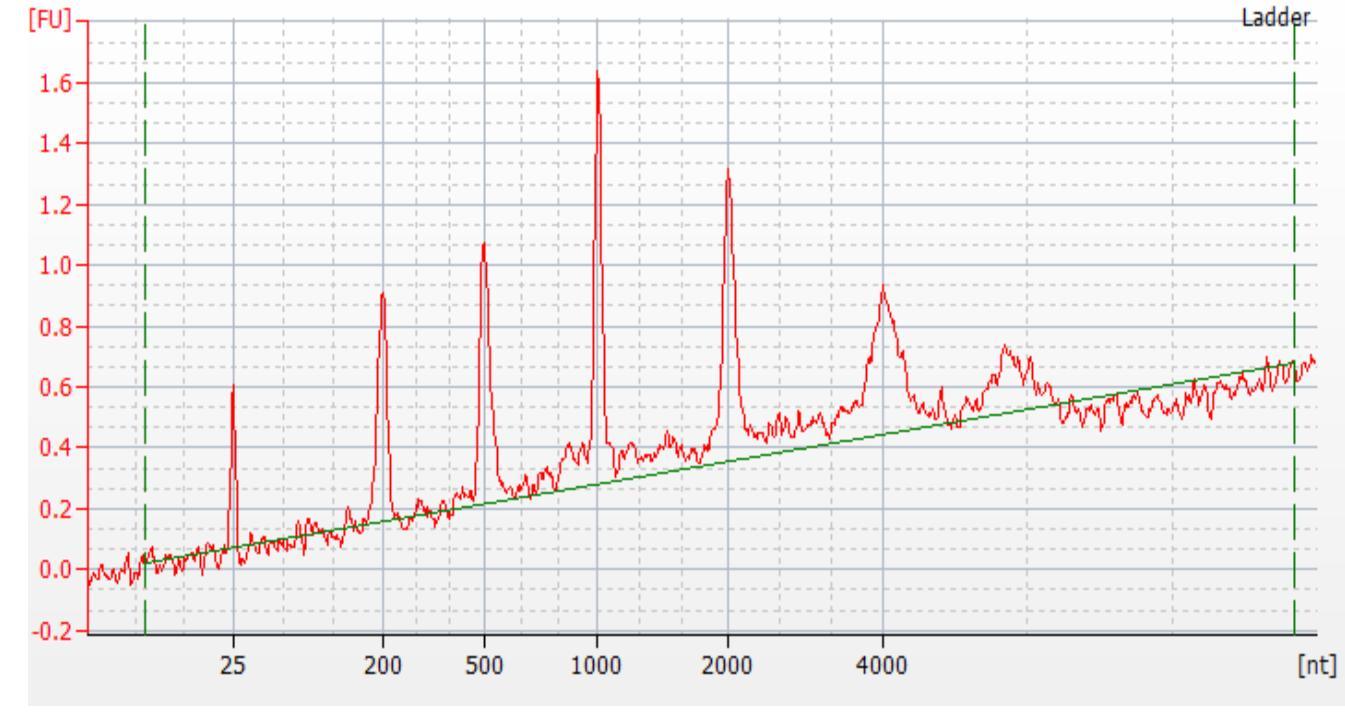
- Prepare a fresh geldye mix; protect dye and gel-dye mix from light
- Check kit (both chips and reagents) is within expiration
- Run full set of hardware diagnostic tests

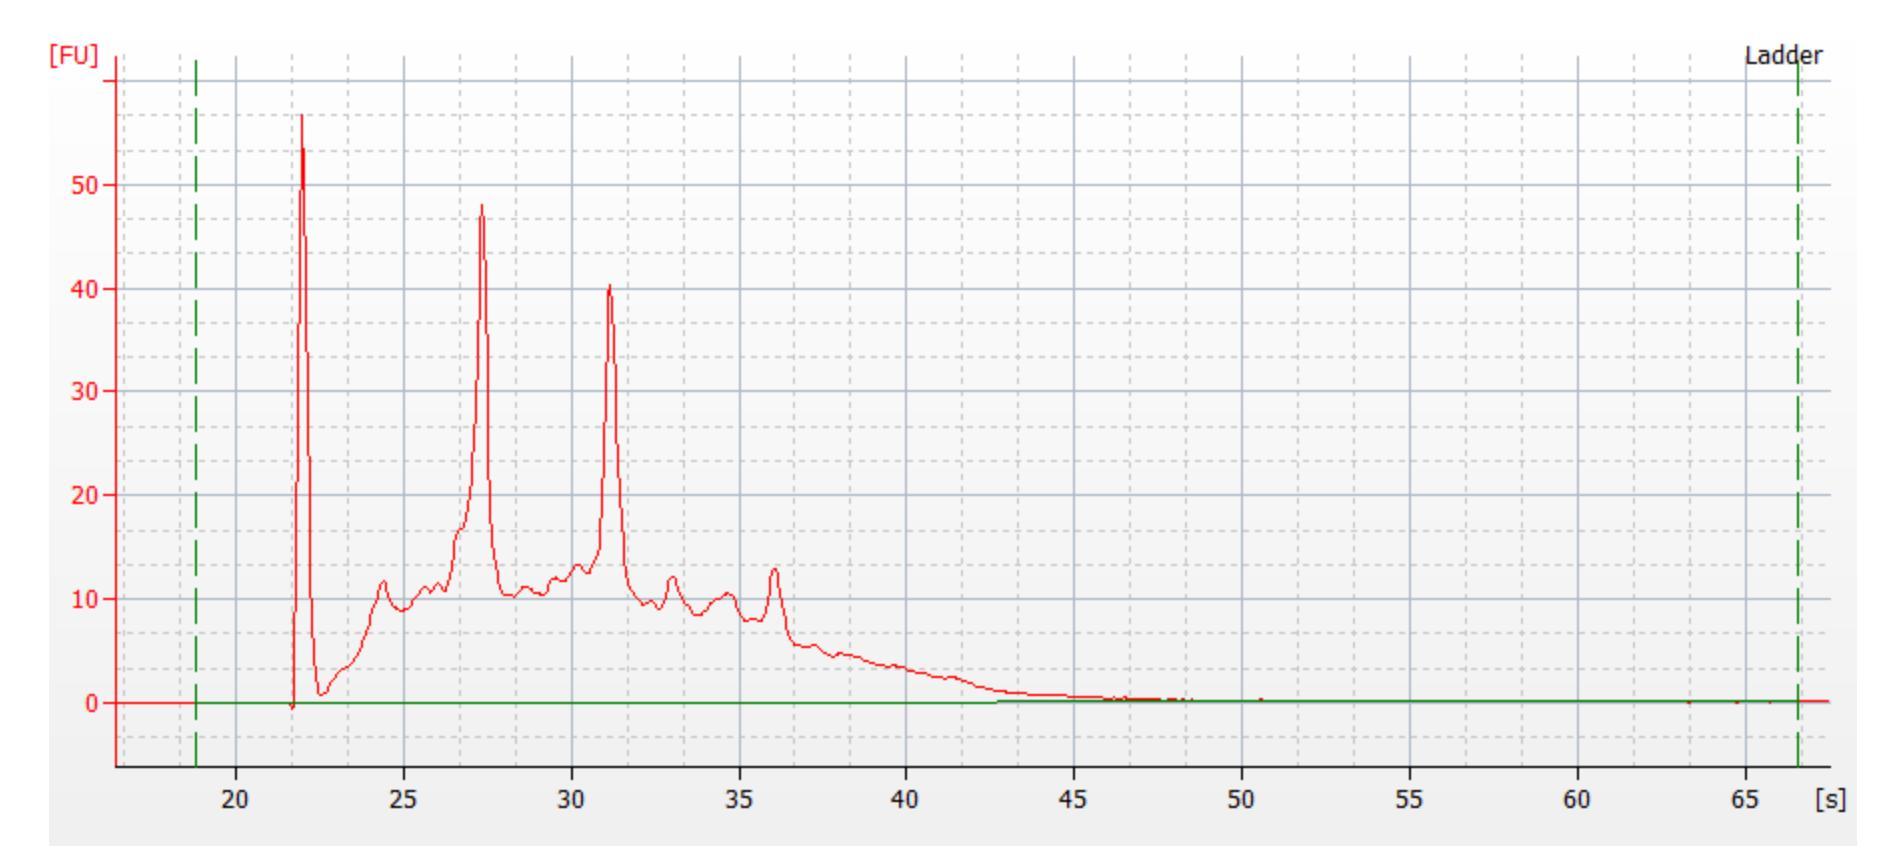
For Research Use Only. Not for use in diagnostic procedures.
Agilent Technologies
Rev. 1 [January 13, 2016]

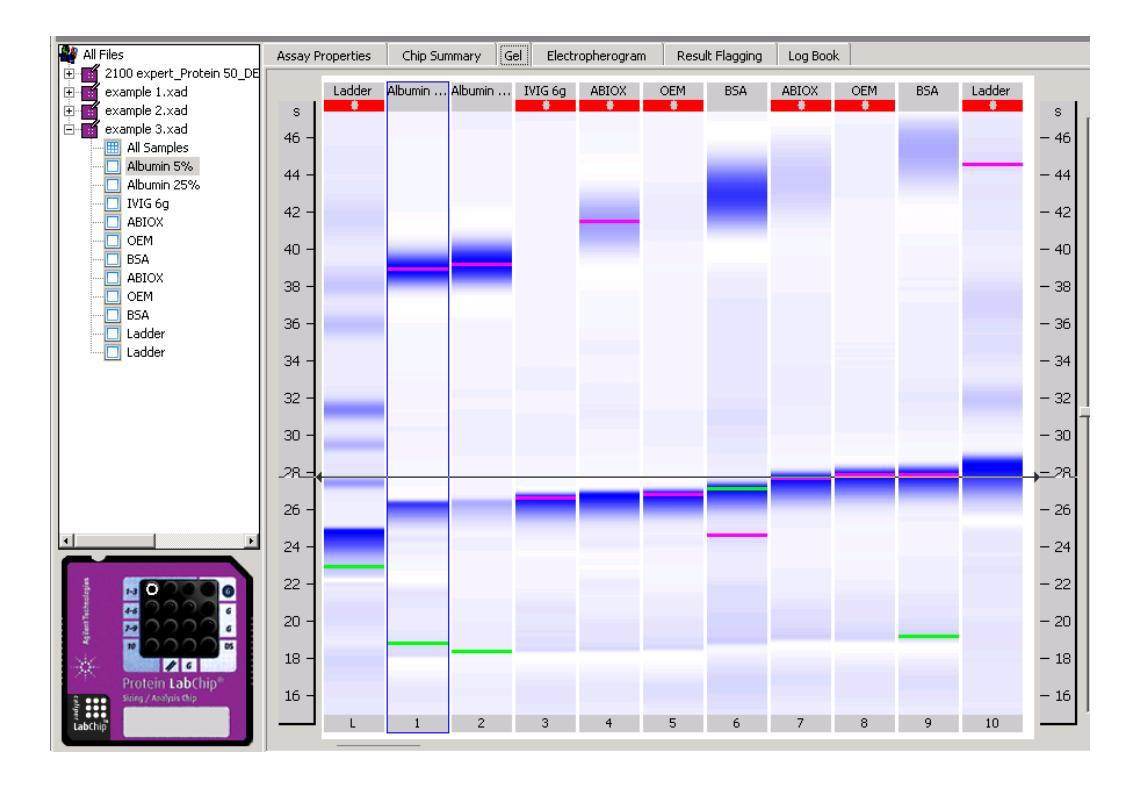
Recommended after chip priming step:
