Troubleshooting BFB Tuning Issues

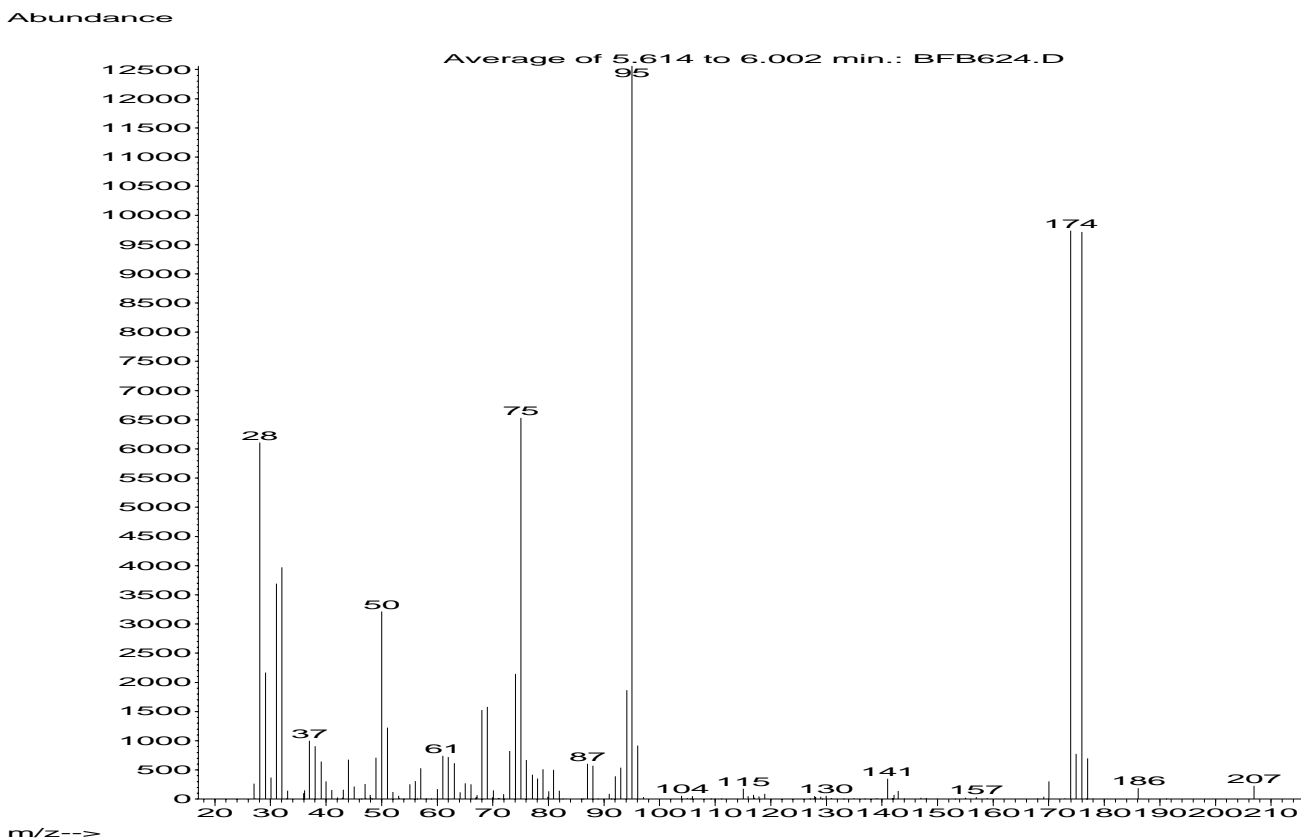
Notice a y-axis abundance for mass 95 of 12,500 counts. If this same solution is used over time, the abundance of mass 95 may be getting smaller. This in turn will usually make the ratio of the 174 also to go down, resulting in the failure to pass the EPA criteria at the higher mass fragment. This is normally due the evaporation of the BFB, which in turn makes the concentration of the BFB lower than what was originally prepared.

In this case, prepare a new solution of BFB from a fresh stock standard. If this is the case, the abundance of the 95 may be more similar to the injection from the BFB that was performed after the last tuning was done.
