Plasma Ignition Troubleshooting For The 4100 MP-AES

Stephen Anderson, September 2012

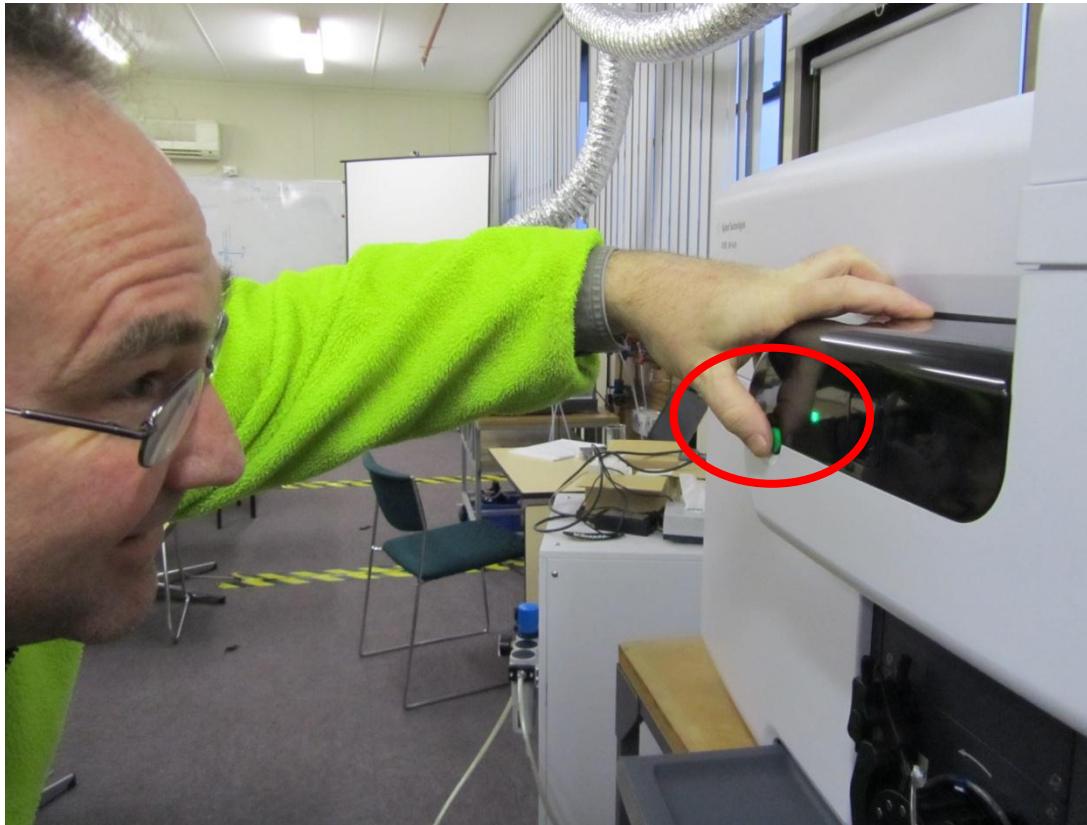
Diagnosing Gas Flows

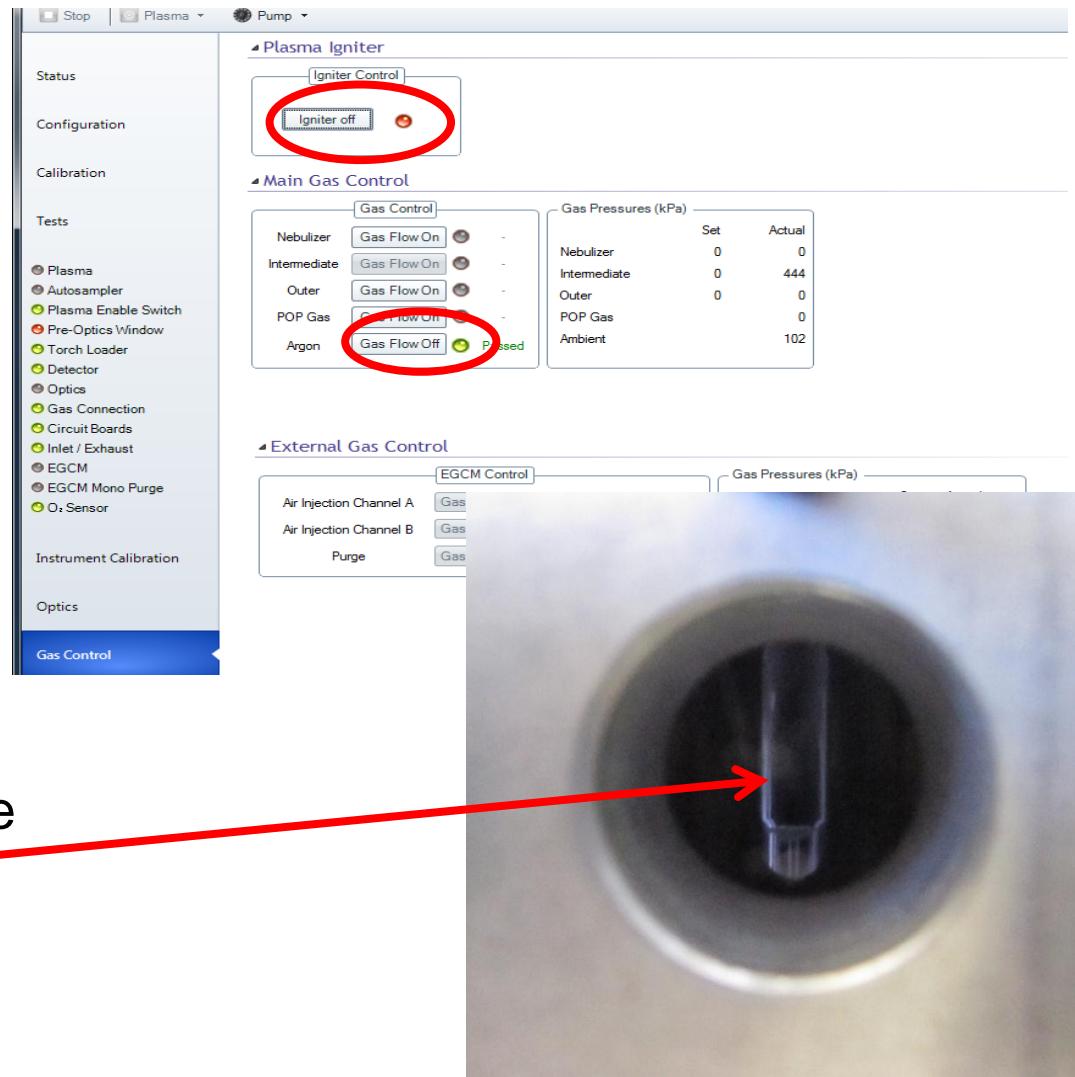
Failure to Detect Igniter Discharge In the Plasma Torch

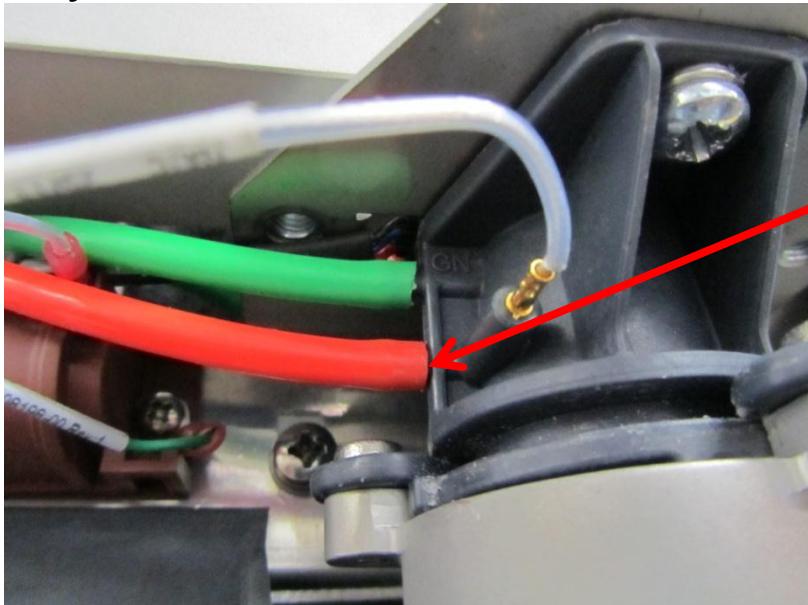
Problems with the Torch Loader Molding Assembly

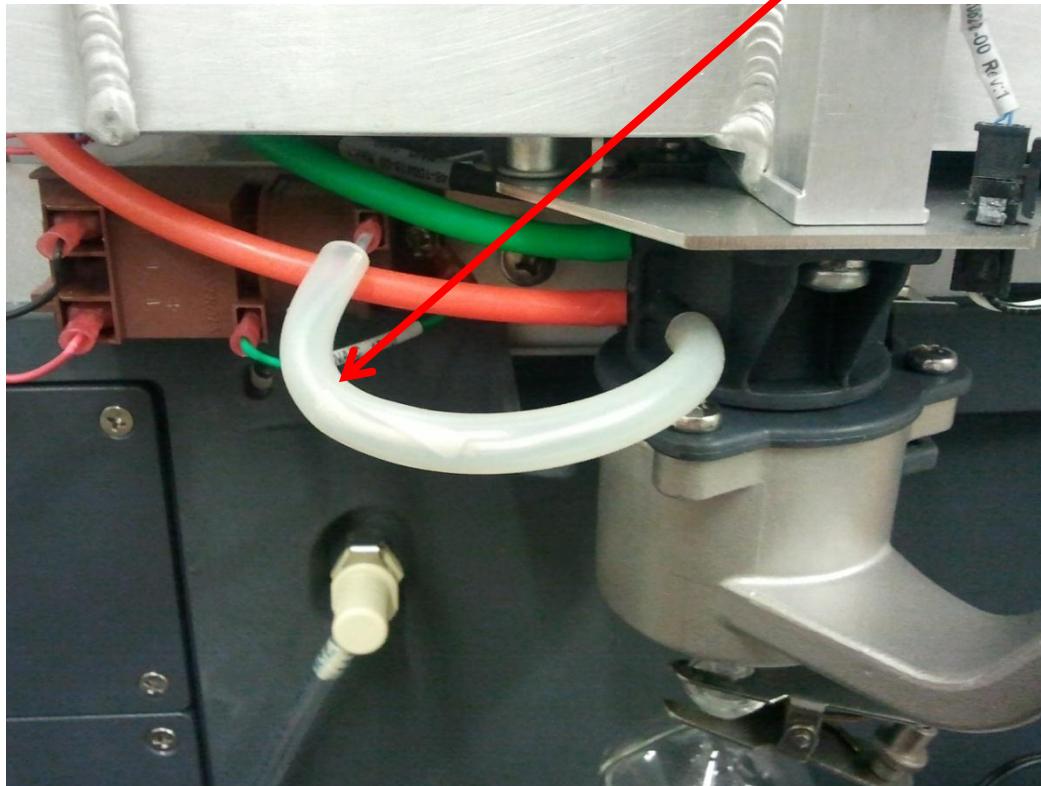
Leaking Gas Connections on the Main Gas Control System and Oxygen Sensor Connections

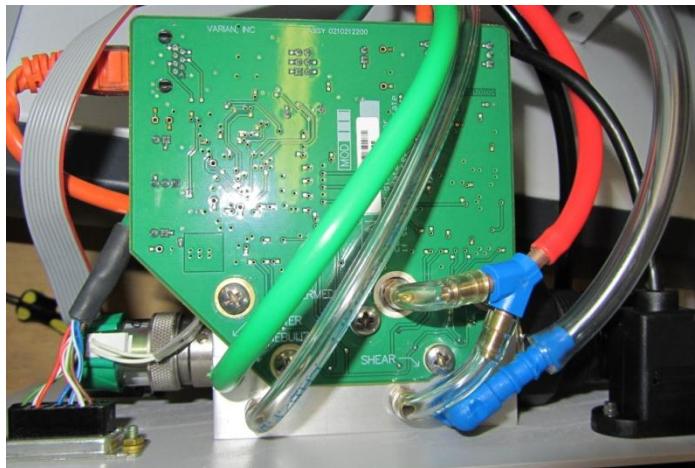
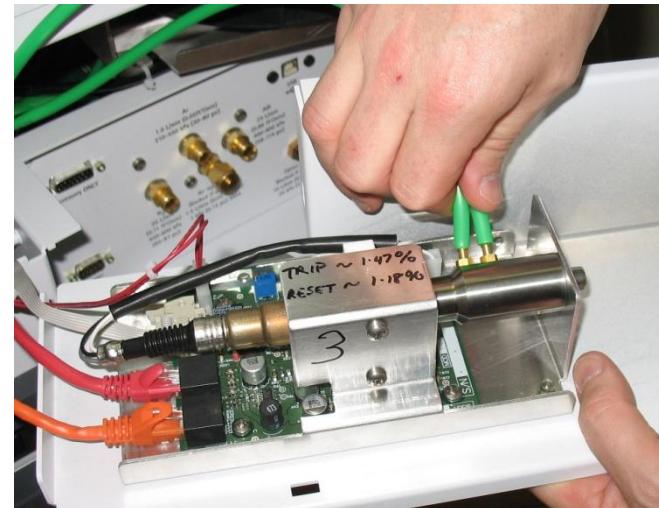
Gas Leaks Due to Loose Solenoid Valve Assembly

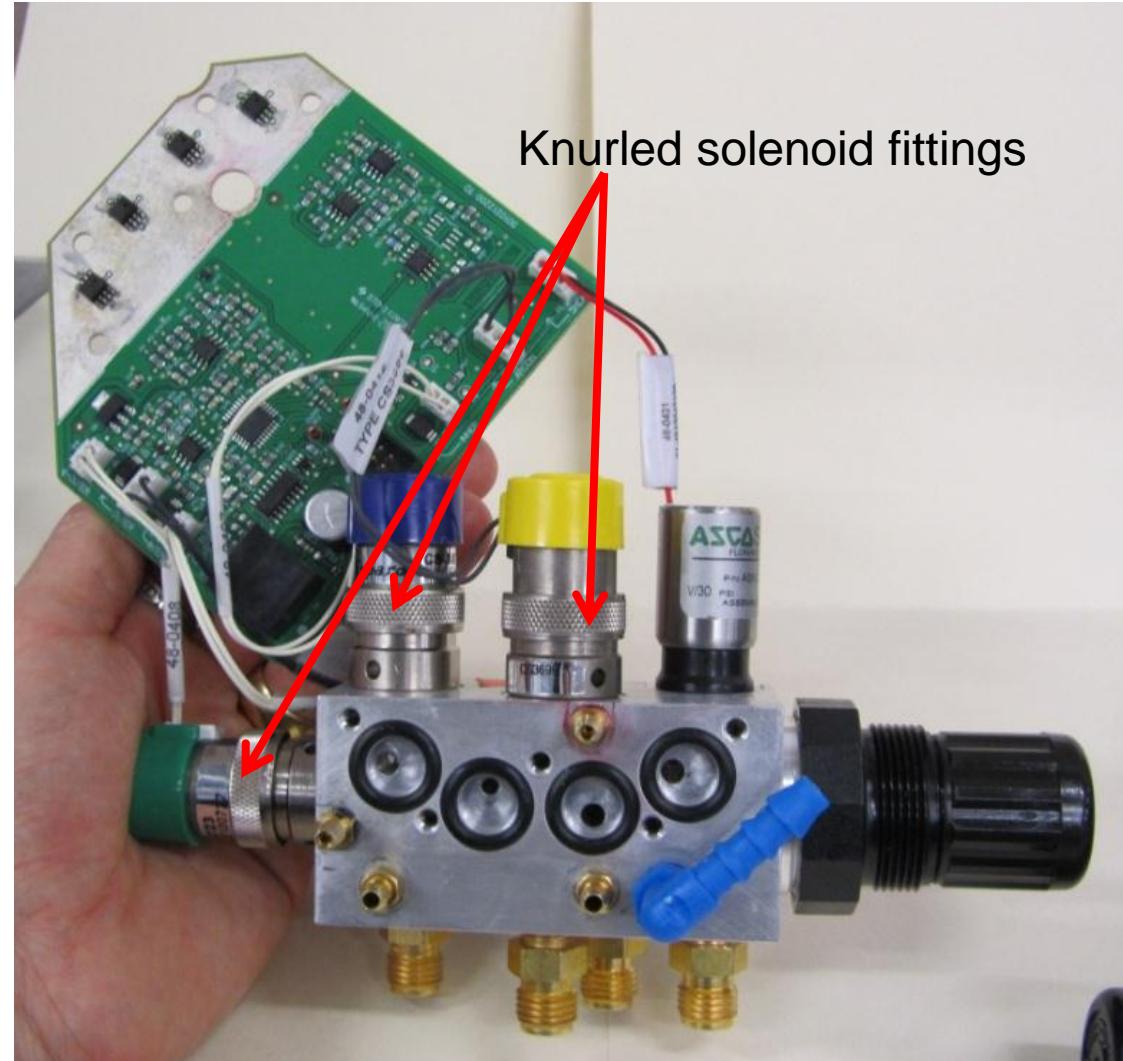
- Confirm the knurled fittings holding the solenoid valve assembly together is NOT loose
- Confirm the Valve is NOT loosely attached to the Manifold

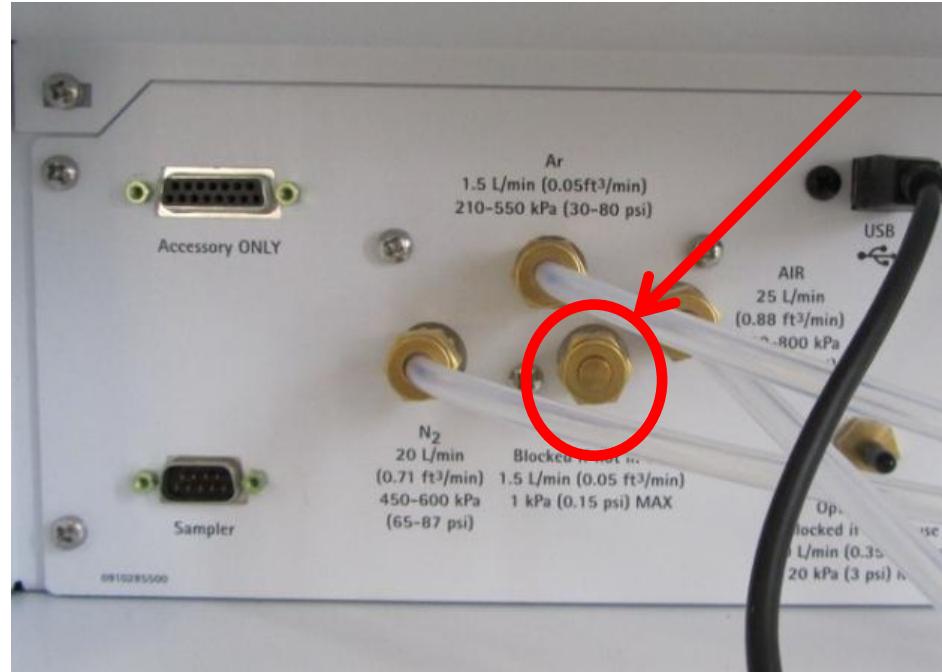
Air Injection via the EGCM

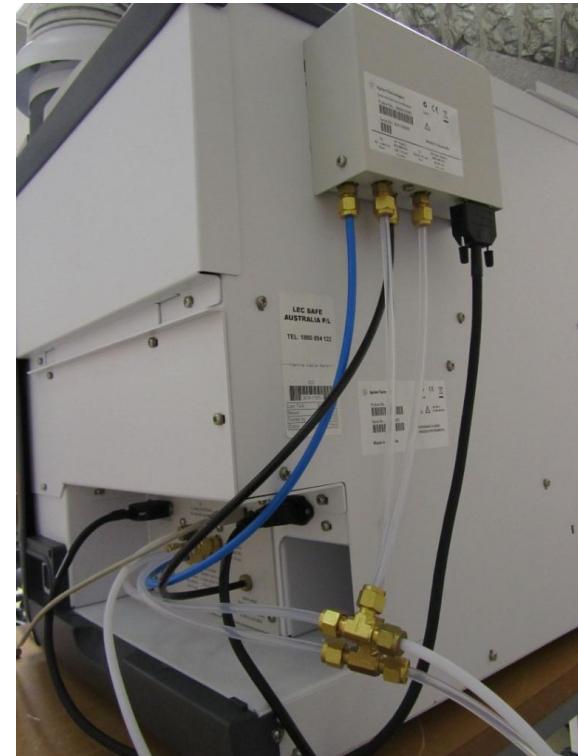
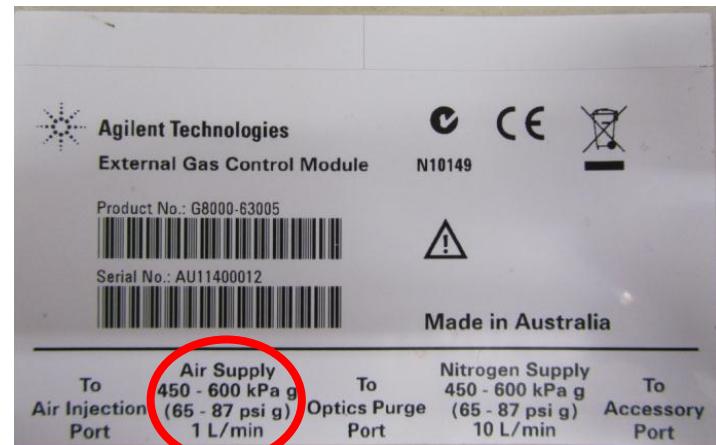
- If an EGCM is connected to the Air Injection port of the Main Gas Control system
 - Confirm the supplied air pressure to the EGCM is within recommended limits
 - Excessive air pressure to the EGCM can cause the solenoid on the EGCM to leak, injecting air into the plasma continuously

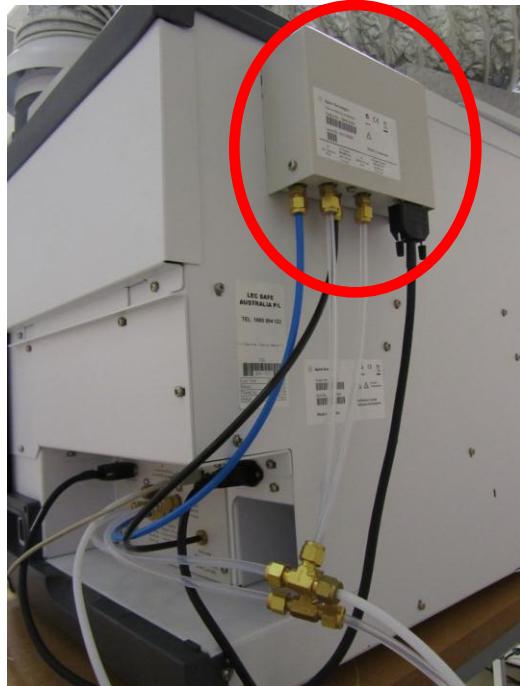
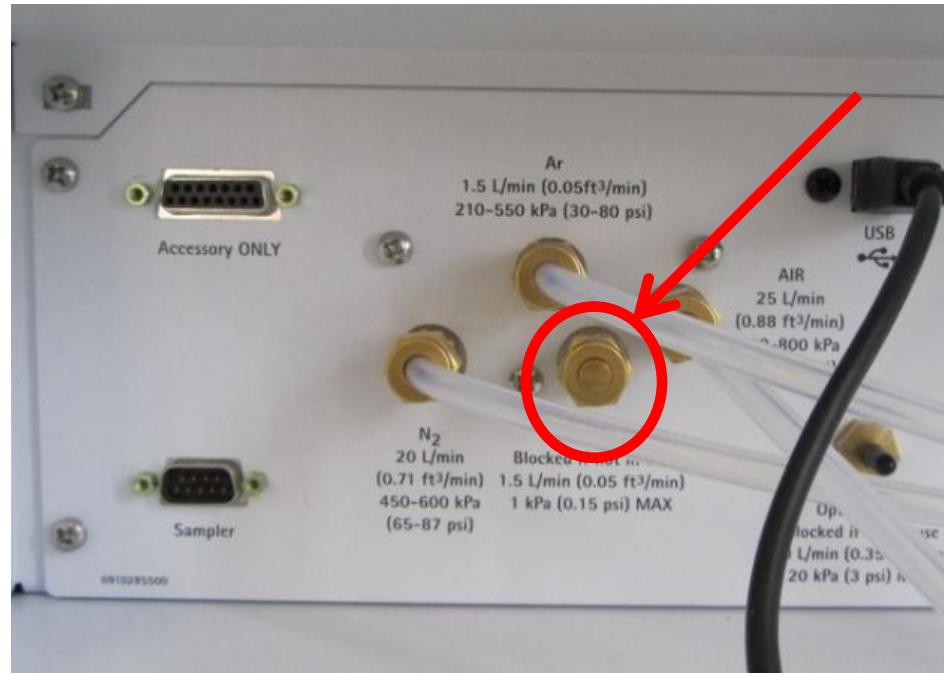
Main Control Board “Blue” LED401, HVEN (High Voltage Enabled)

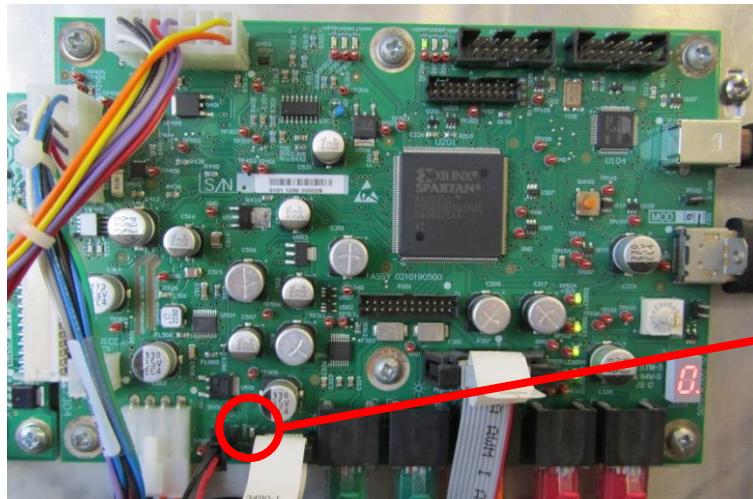
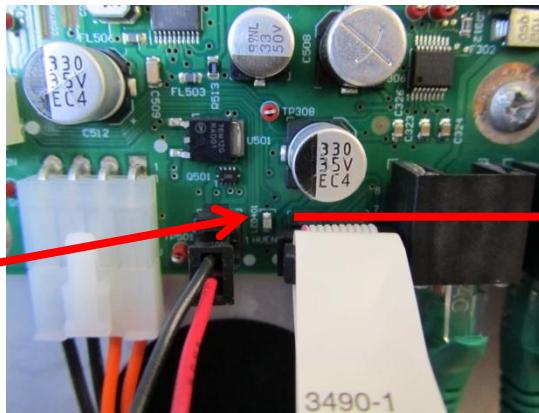
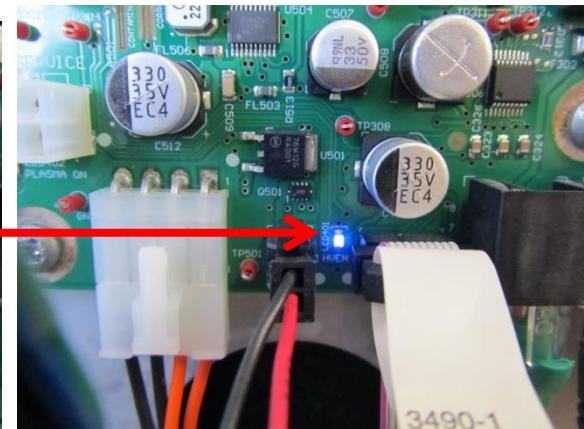
Check Electrical Connection to the HVPS
