Agilent 2100 Bioanalyzer System

Maintenance and Troubleshooting Guide

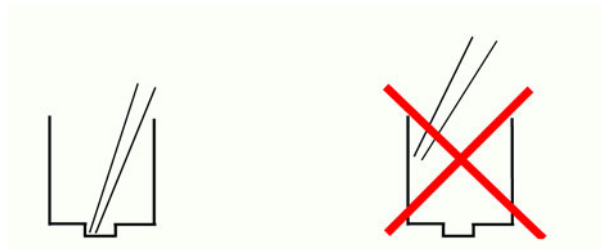
- Use a new syringe and electrode cleaner with each new kit.

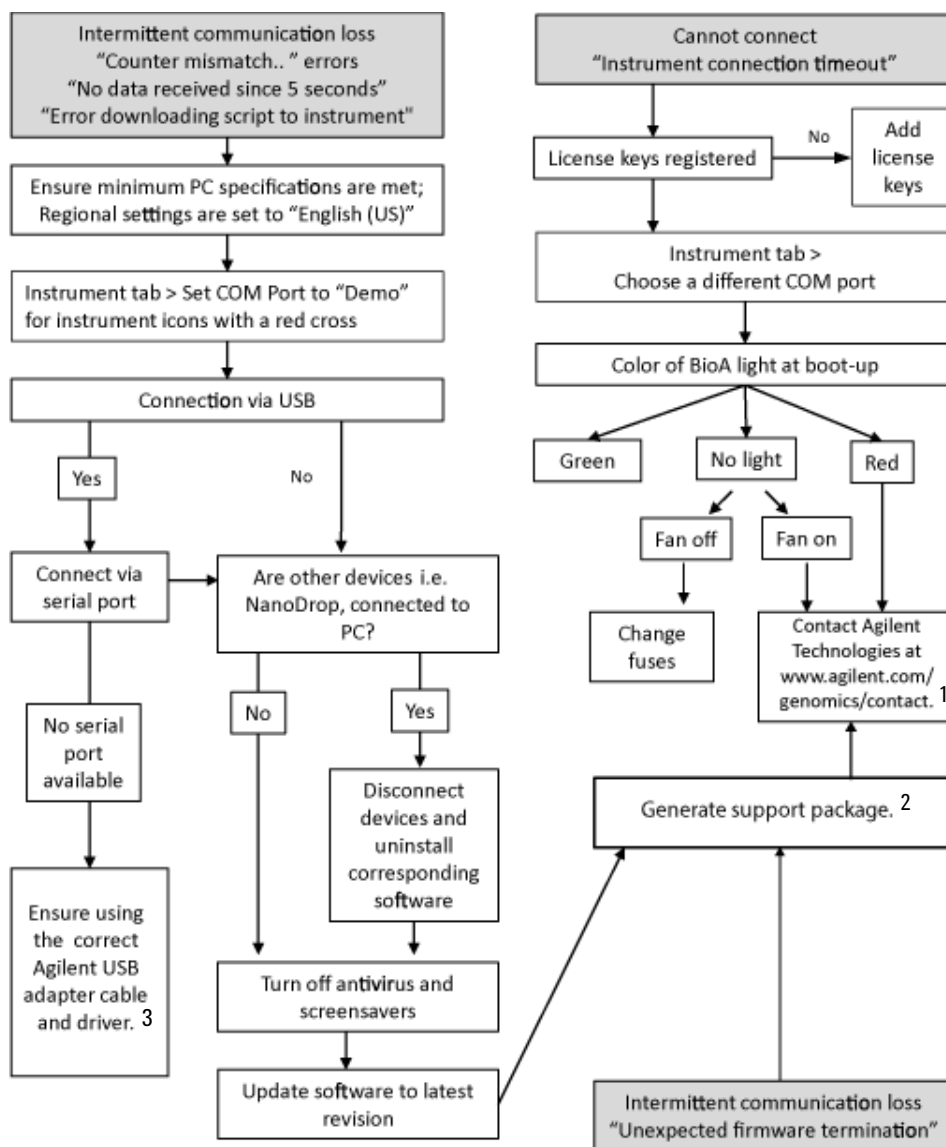
1 <https://www.agilent.com/en/contact-us/page>

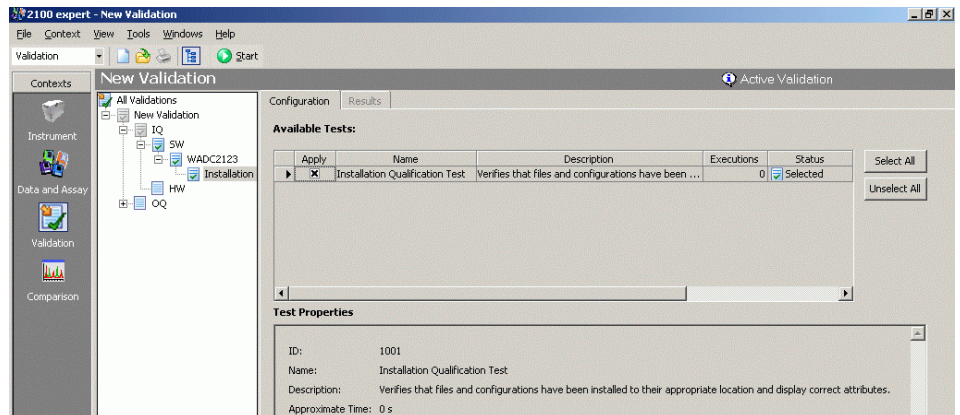
- 4 Start the software test tool by clicking **Start**.
- 5 The **Save As** dialog box appears. Define the name and location of the verification file.
- 6 When the test is finished, the **Verification Run Complete** message appears.

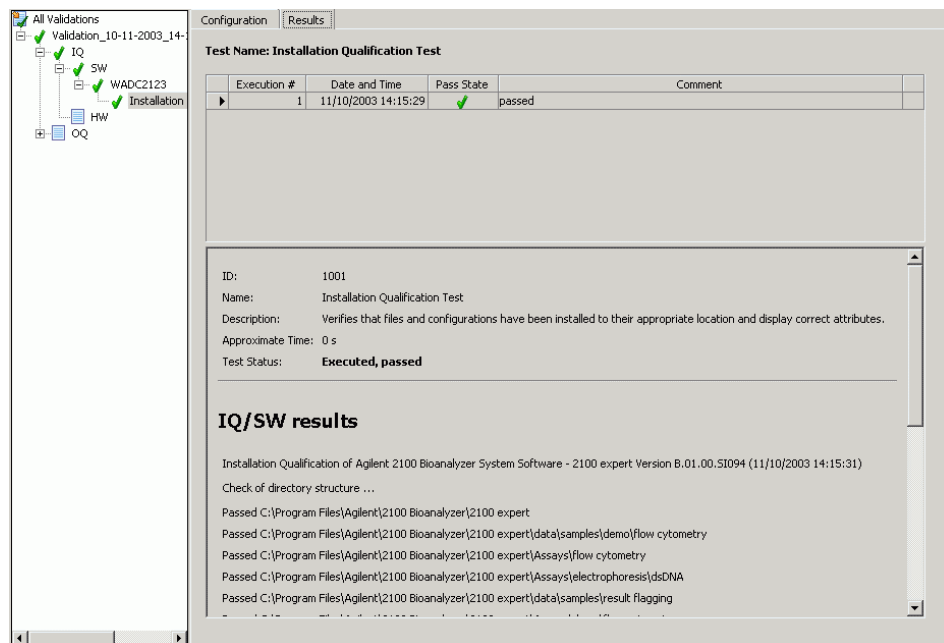
- 8 If the test passes and the 2100 Bioanalyzer system still does not function properly, see ["Verify the Instrument Communication"](#) on page 15 and ["Overview"](#) on page 27 for further troubleshooting procedures. Finally, to check the application, see ["Overview"](#) on page 32, ["Overview"](#) on page 63 , or ["Overview"](#) on page 84.
- 9 If the test fails, reinstall the 2100 Expert Software using the software UFD media that is supplied with the system.
- 10 If the test continues to fail, contact Agilent Technologies at <https://www.agilent.com/en/contact-us/page>.

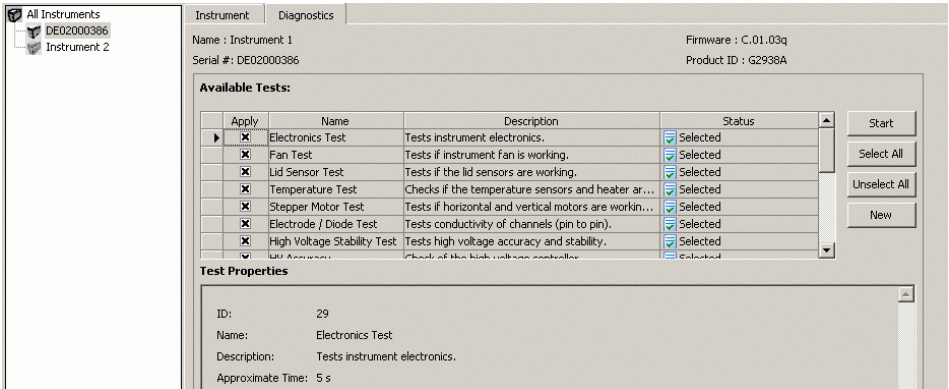
- 5 Select **Start** and follow the instructions as given by the 2100 Expert Software.
- 6 At the end of the procedure, all tests must have passed.

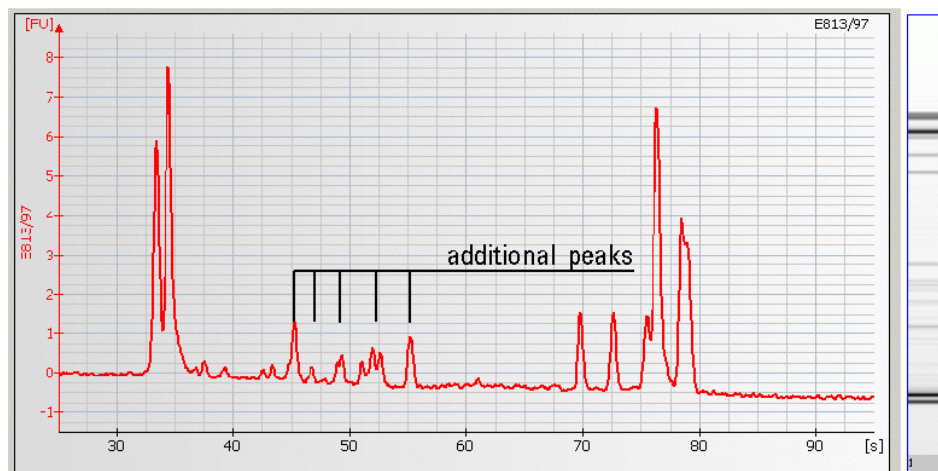
Additional Sample or Ladder Peaks

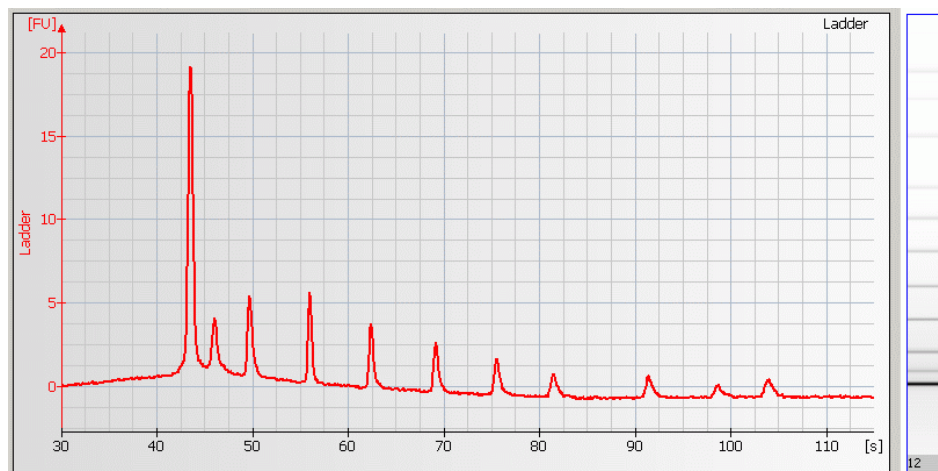
Most probable causes

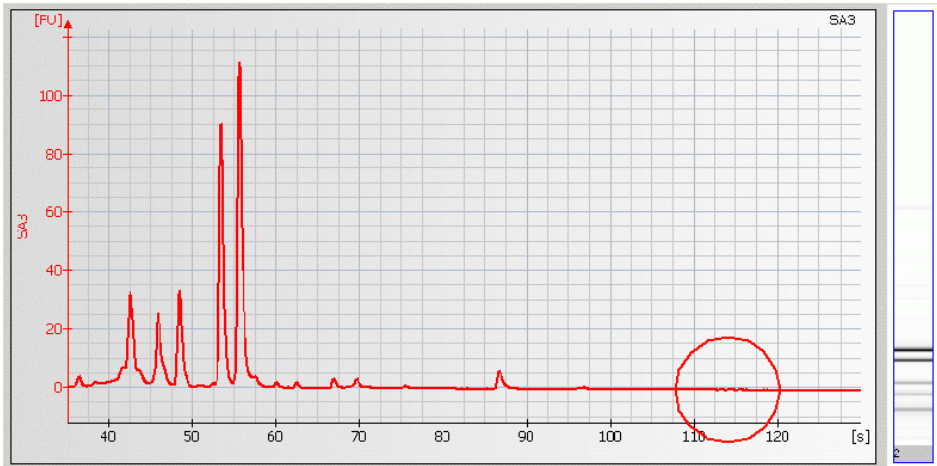
Most probable causes	Solution
Alignment of upper marker not set properly.	Manually assign upper marker. Follow instructions for “Manual Marker Assignment” on page 54
Upper marker digested by restriction enzymes.	Inactivate restriction enzymes by adding EDTA or heat according to the manufacturer's instructions.
Probable causes	Solution
Sample salt concentration is too high.	Refer to the maximum sample buffer salt limits as specified in the Kit Guide. Dilute samples with deionized DNase free water if necessary.

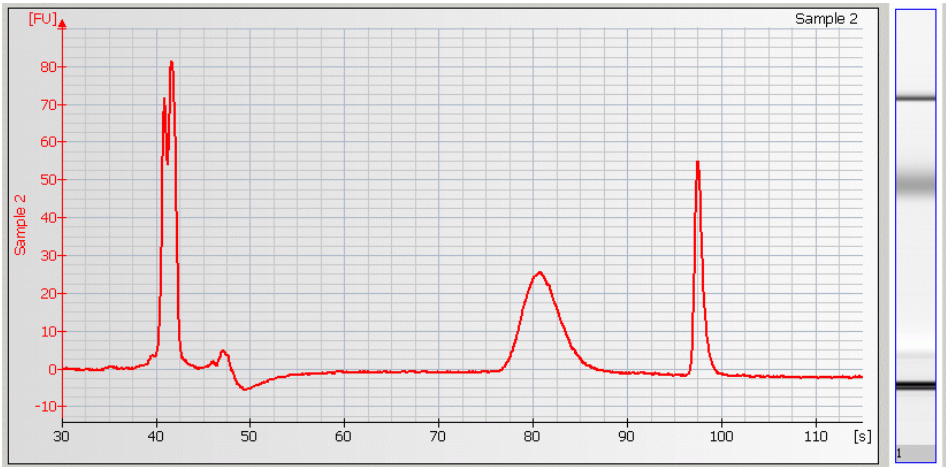
Most probable causes	Solution
Leak currents due to contaminated electrodes.	Clean electrodes with analysis-grade water and a toothbrush, see "How to Clean the Pin Set of the Electrode Cartridge" on page 121.
Chip not properly primed. Clogged chip priming station or wrong priming station settings.	Prepare a new chip. Check the priming station as described in "Checking the Chip Priming Station for Proper Performance - Seal Test" on page 134. Clean/replace syringe, gasket and plastic adapter, if necessary. Check if clip and base plate of priming station are in the correct position (see Kit Guide).
Dye concentration too high.	Use dye concentration according to the Kit Guide. Let the dye warm up to room temperature for 30 minutes before preparing the gel-dye mix.
Probable causes	Solution
Genomic DNA or cDNA contamination.	Check DNA preparation procedure.

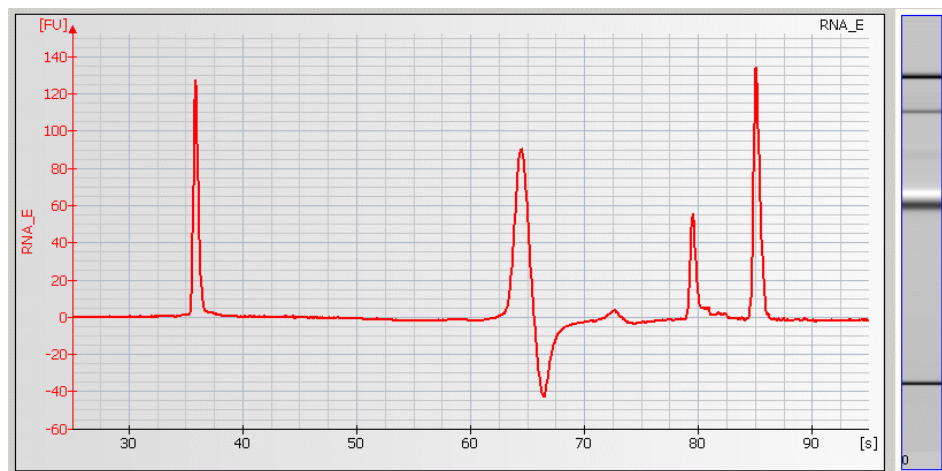
<i>Most probable causes</i>	<i>Solution</i>
Sample concentration is too high.	Use sample concentration according to the Kit Guide.
Sample impurities: e.g. genomic DNA, ss DNA, etc.	Check DNA-isolation protocol. If possible, clean up samples.
<i>Probable causes</i>	<i>Solution</i>
Sample salt concentration is too high.	Refer to the maximum sample buffer salt limits as specified in the Kit Guide. Dilute samples with deionized DNase free water, if necessary.
Dye concentration is too low.	Use dye concentration according to the Kit Guide. Let the dye warm up to room temperature for 30 minutes before preparing the gel-dye mix. Protect the dye from light during this time.
<i>Least probable causes</i>	<i>Solution</i>
Autofocus failure.	Check autofocus by means of the "Overview" on page 27. If the diagnostic test fails, contact Agilent Technologies at https://www.agilent.com/en/contact-us/page .

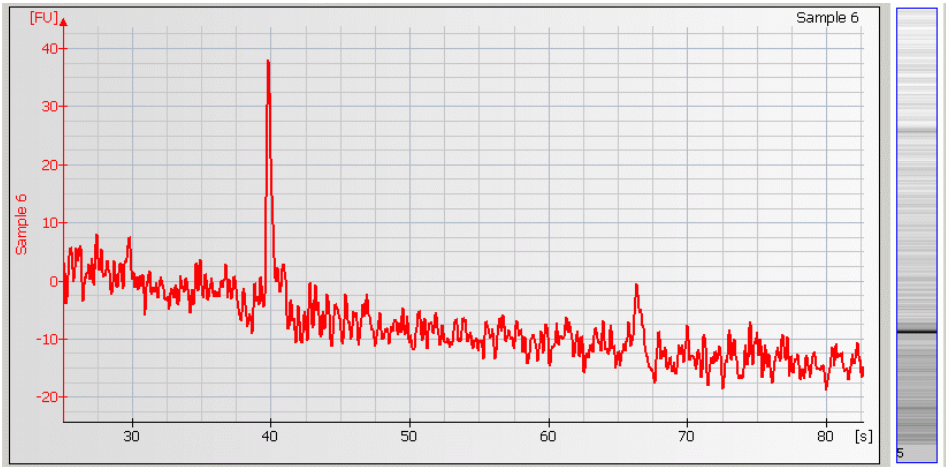
Most probable causes	Solution
Chip contaminated.	Wear powder-free gloves only. Do not touch the underside of the chip. Do not touch the wells of the chip. Clean the electrodes. Load the chip immediately after taking it out of its sealed bag.
Probable causes	Solution
Fingerprint on focusing lens or on the backside of the chip.	Clean lens as described in "Cleaning the Lens" on page 138. Do not touch the underside of the chip.
Least probable causes	Solution
Autofocus failure or high voltage power supply defective.	Check autofocus and high voltage power supply by means of the "Hardware Diagnostics" on page 26. If tests fail, contact Agilent Technologies at https://www.agilent.com/en/contact-us/page .

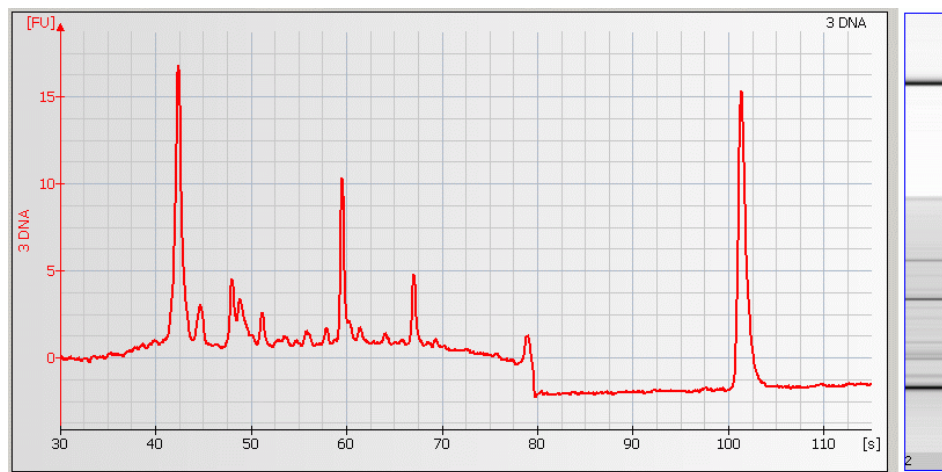
<i>Most probable causes</i>	<i>Solution</i>
Vibration of 2100 Bioanalyzer instrument.	Remove vibration devices, such as vortexers and vacuum pumps, from bench.
Instrument lid was touched during the run.	Do not touch the 2100 Bioanalyzer instrument during a run.
<i>Least probable causes</i>	<i>Solution</i>
Laser defective.	Check laser using the “ Hardware Diagnostics ” on page 26. If the diagnostic test fails, contact Agilent Technologies at https://www.agilent.com/en/contact-us/page .

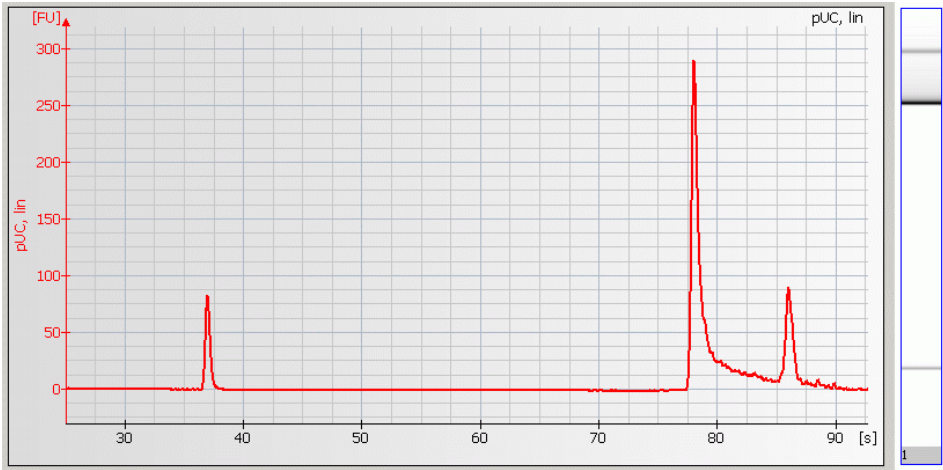
Most probable causes	Solution
Sample salt concentration is too high.	Refer to the maximum sample buffer salt limits as specified in the Kit Guide. Dilute samples with deionized DNase free water, if necessary.

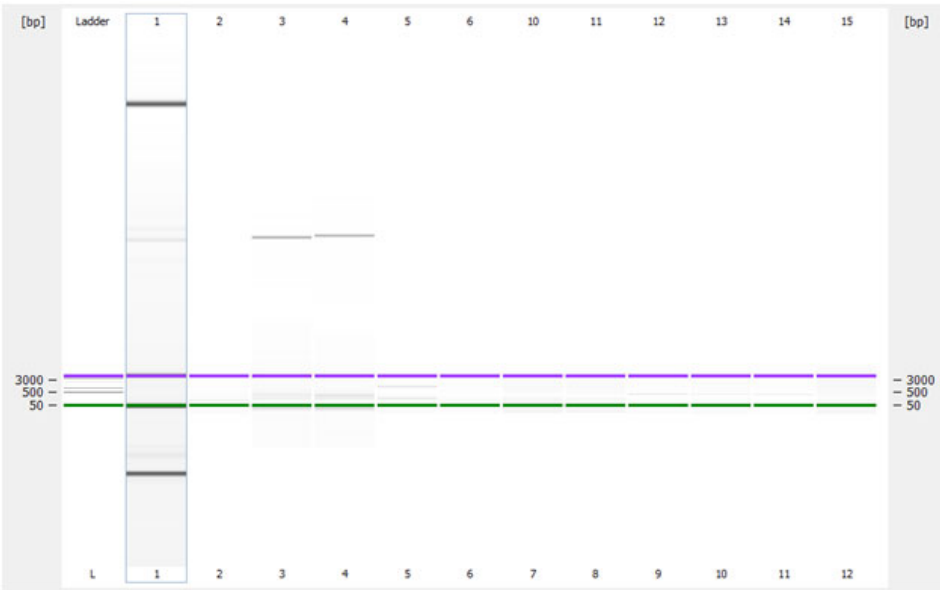
Most probable causes

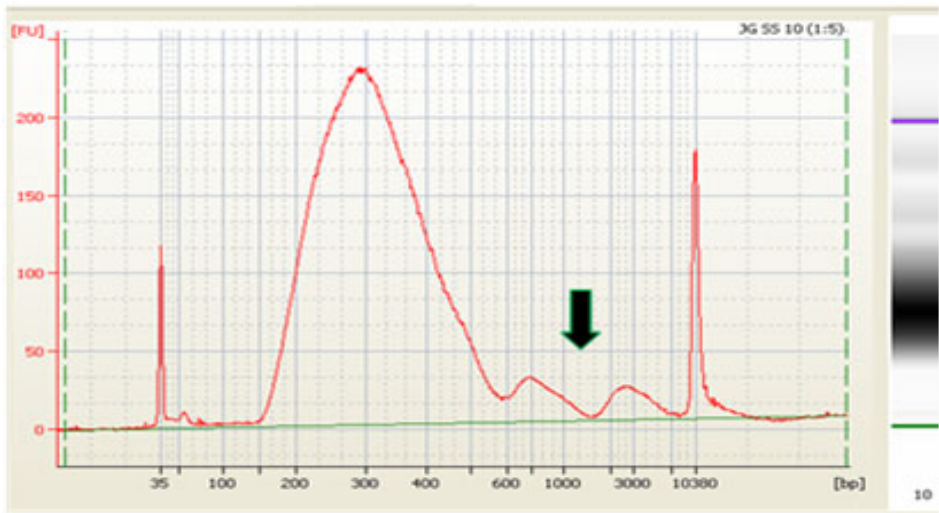
Most probable causes	Solution
Samples are in water.	Refer to the Kit Guide for sample buffer specifications. For optimal results, samples should be dissolved in 10 mM Tris and 1 mM EDTA.
Probable causes	Solution
Chip, gel-dye mix, or samples are contaminated with particles.	Wear powder-free gloves only. Do not touch the wells of the chip. Clean the electrodes. Load the chip immediately after taking it out of its sealed bag.

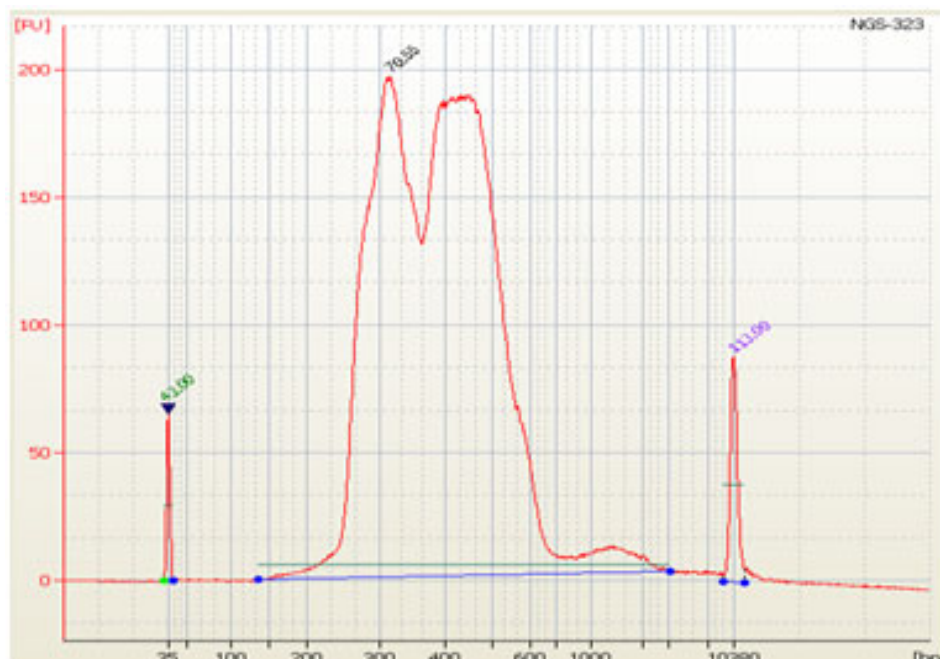
Most probable causes

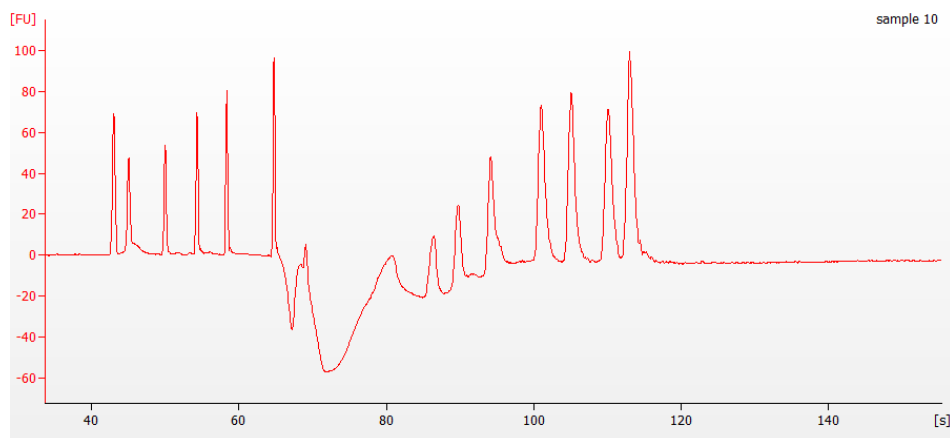
Most probable causes

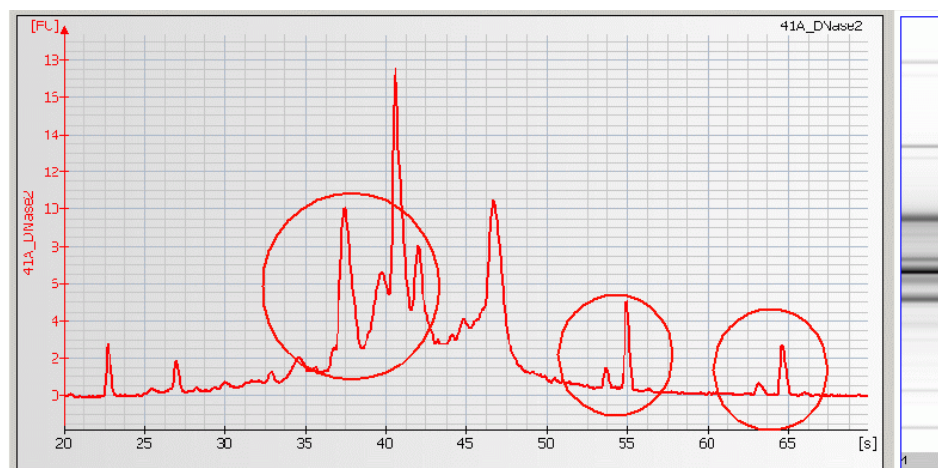
Additional Sample or Ladder Peaks

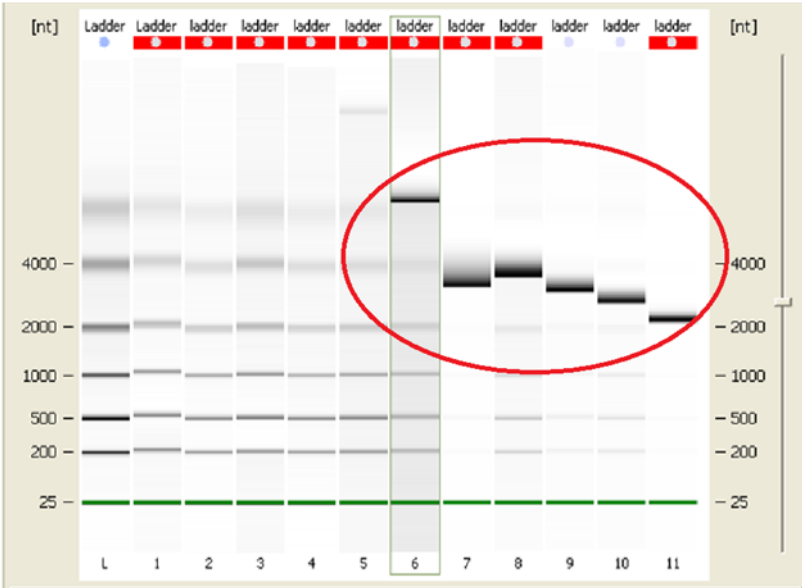
Most probable causes

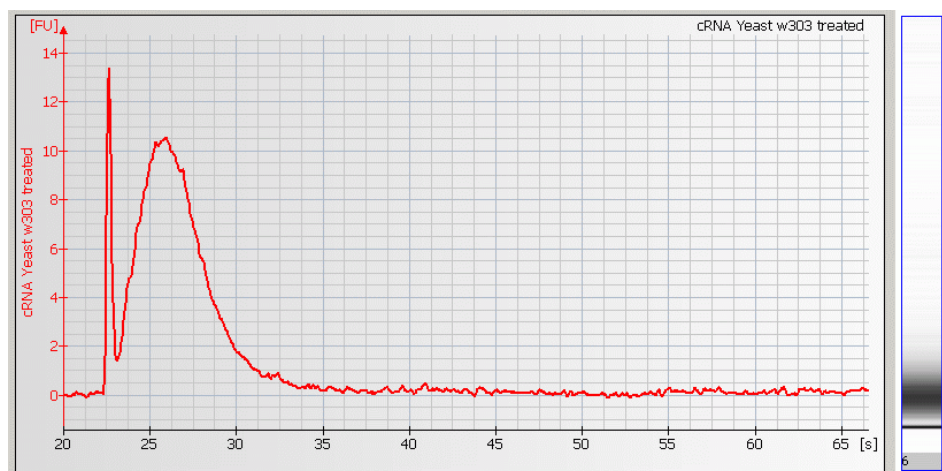
<i>Most probable causes</i>	<i>Solution</i>
RNase contamination of the pin set.	Decontaminate pin set. Follow decontamination procedure, see "How to Clean the Pin Set of the Electrode Cartridge" on page 121. Decontaminate pipettes and work space.
RNase contamination of chips and/or reagents.	Prepare a new chip and fresh reagents. Wear powder-free gloves when preparing the chip. Decontaminate pipettes and work space.

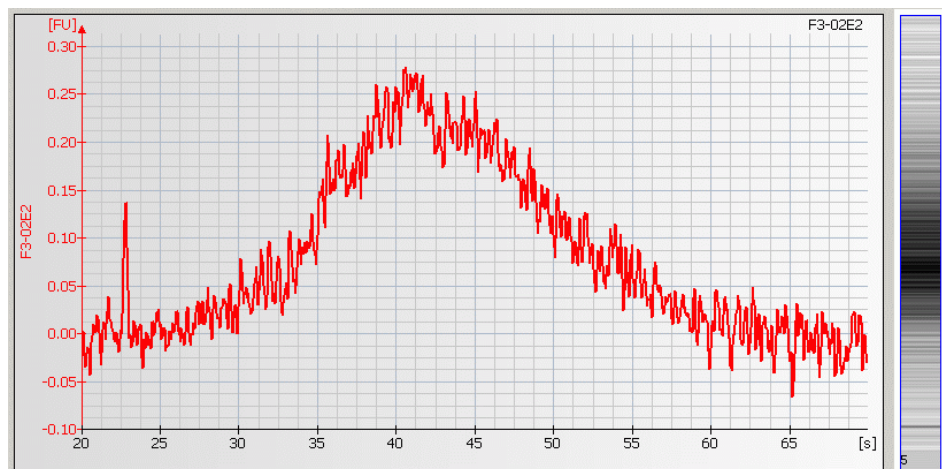
Low Signal Intensity

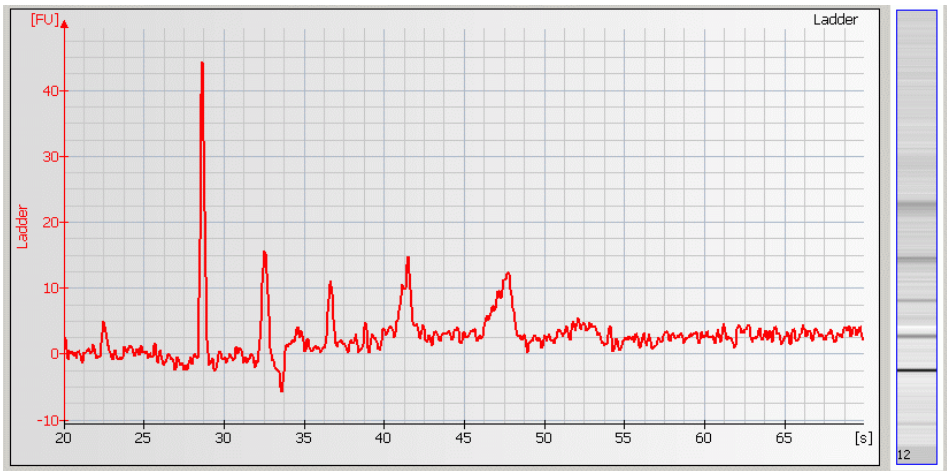
Most probable causes	Solution
Fingerprint on focusing lens or on the backside of the chip.	Clean lens as described in “Cleaning the Lens” on page 138. Do not touch the underside of the chip.
Chip contaminated with particles.	Wear powder-free gloves only. Do not touch the underside of the chip. Do not touch the wells of the chip. Clean the electrodes. Load the chip immediately after taking it out of its sealed bag.
Vibration of 2100 Bioanalyzer instrument.	Do not touch the 2100 Bioanalyzer instrument during a run. Remove vibration devices, such as vortexers and vacuum pumps, from the bench.
Probable causes	Solution
Dye concentration too low.	Use dye concentration according to the Kit Guide. Let the dye warm up to room temperature for 30 minutes before preparing the gel-dye mix. Protect the dye from light during this time.

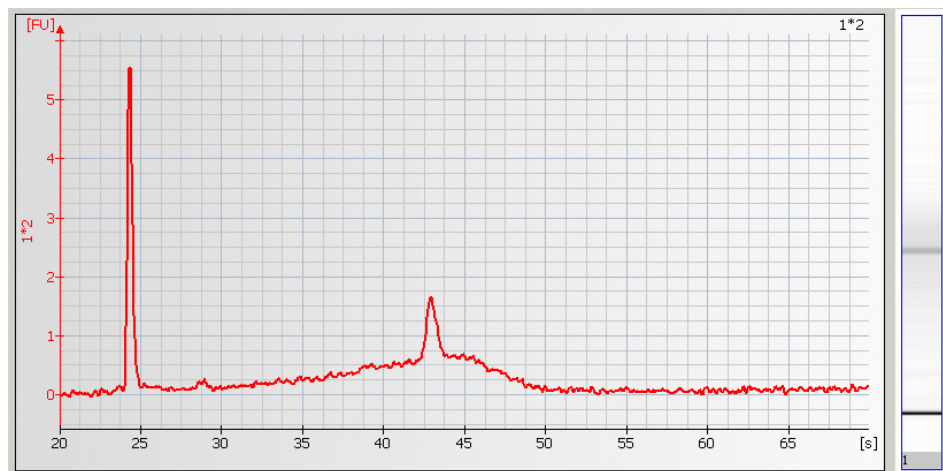
<i>Most probable causes</i>	<i>Solution</i>
Sample salt concentration is too high.	Refer to the maximum sample buffer salt limits as specified in the Kit Guide. Dilute samples with deionized RNase free water, if necessary,
<i>Probable causes</i>	<i>Solution</i>
RNase contamination of electrodes or reagents.	Clean electrodes with RNaseZAP. Follow cleaning procedure, see “How to Clean the Pin Set of the Electrode Cartridge” on page 121. Prepare a new chip with fresh reagents. Wear powder-free gloves when preparing the chip.

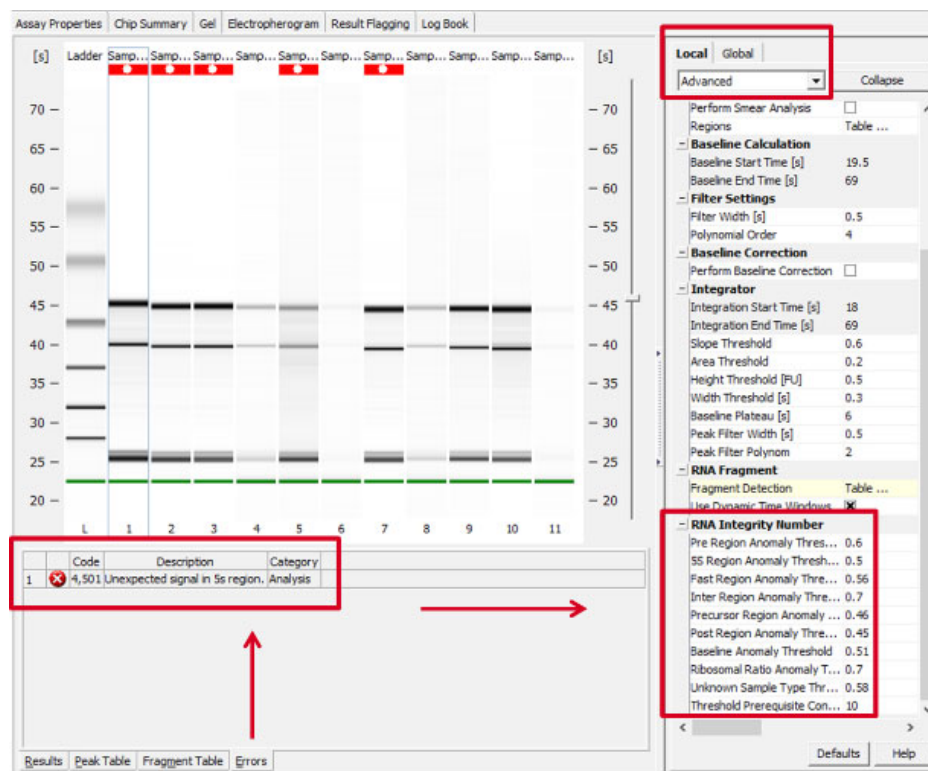
Most probable causes	Solution
Incorrect Assay selected.	Check the sample type. Prepare a new Chip and re-run the samples selecting the correct Assay.
Incorrect assignment of the Lower Marker.	Please refer to Chapter "Troubleshooting the RNA Application" on page 62 to solve the problem. Prepare a new Chip and re-run the samples.
Incorrect assignment of the ribosomal bands.	Please refer to Chapter "Troubleshooting the RNA Application" on page 62 to solve the problem and re-run the samples.
Samples not heat denatured.	Heat the samples 2 min at 70 °C as described in the Kit guide. Prepare a new Chip and re-run the samples.
Un-expected signal anomalies detected in the samples (Error message Unexpected signal...).	Modify predefined thresholds for anomaly detection to clear the error message and get RIN displayed.

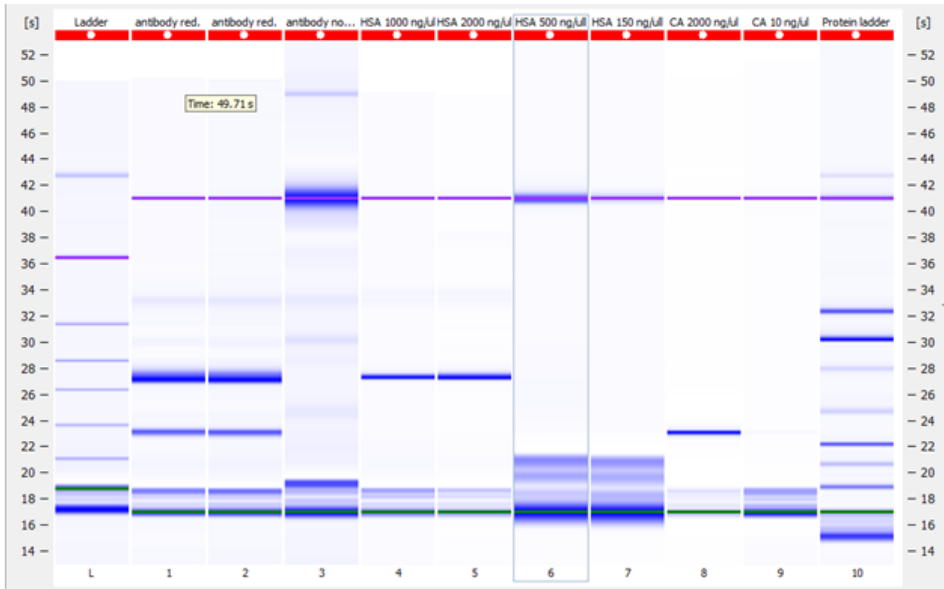
Most probable causes	Solution
Lower and/or upper markers are called incorrectly.	Turn off alignment and check which bands are the correct lower and upper markers. For more details see "Manual Marker Assignment" on page 92 .
Least probable causes	Solution
Bent electrode pin.	Check if electrode pins are bent or damaged. Replace electrophoresis cartridge.

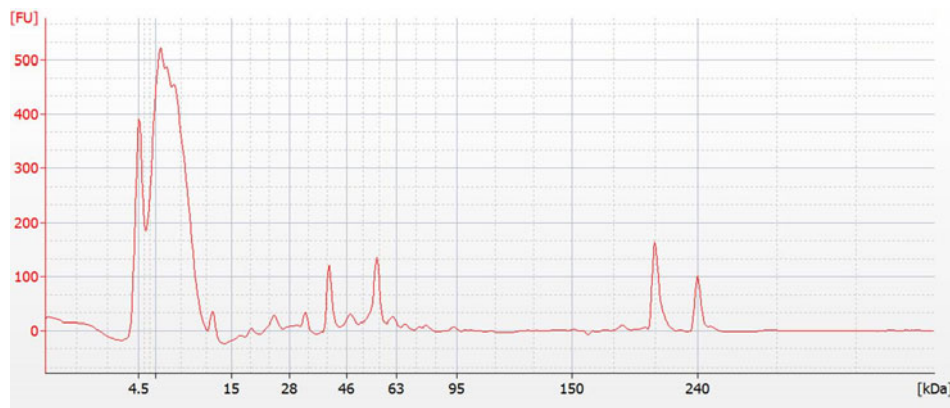
Additional Sample or Ladder Peaks

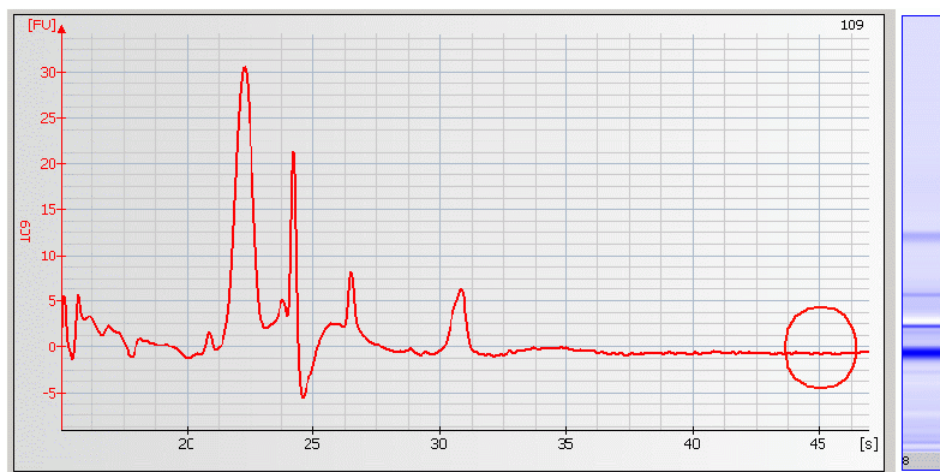
Missing Upper Marker

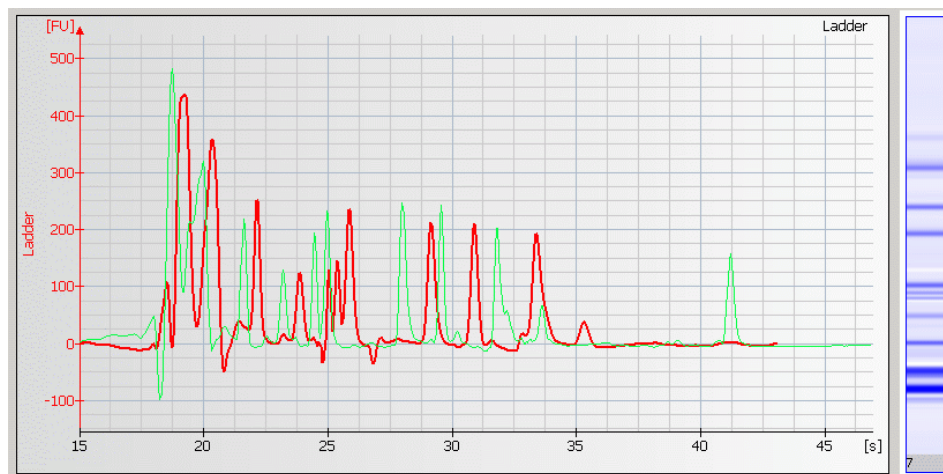
Poor Reproducibility

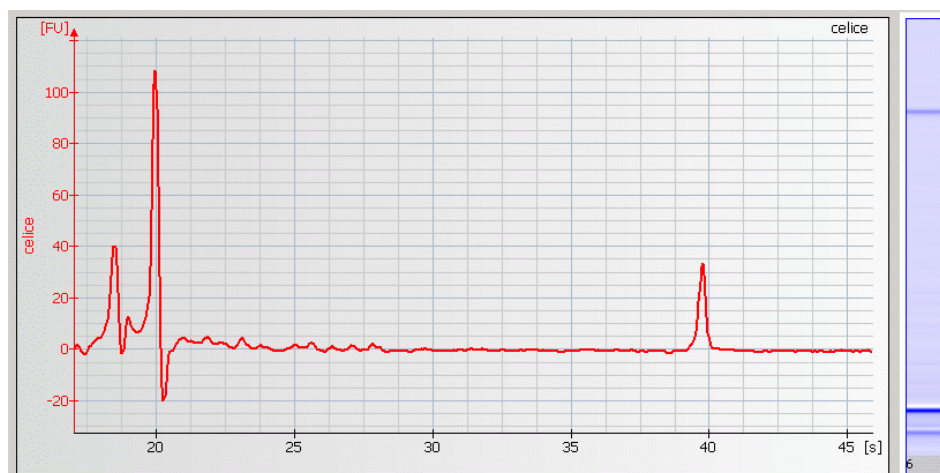
Low Signal Intensity

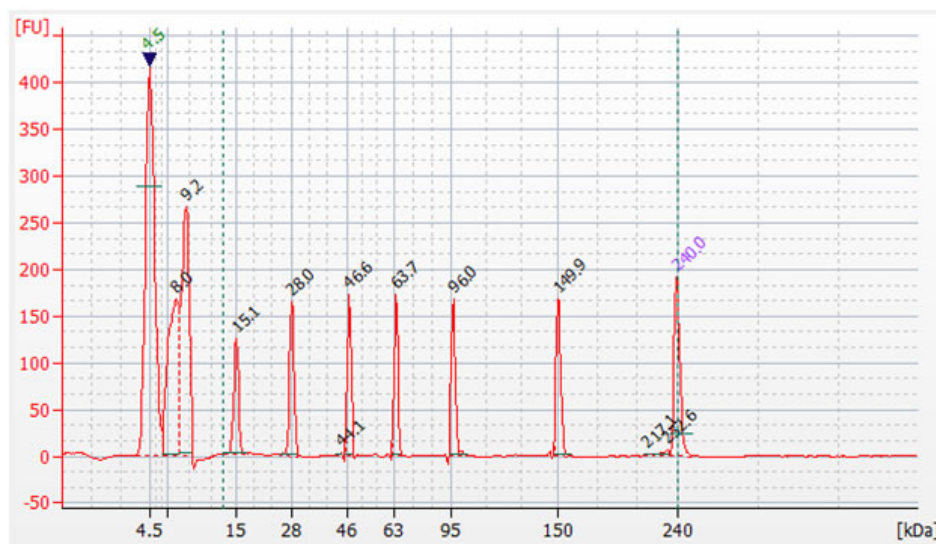
<i>Most probable causes</i>	<i>Solution</i>
Ladder degraded.	Refer to the Kit Guide for proper ladder storage. Optional: Prepare ladder aliquots and use a new aliquot.
Ladder not diluted after denaturing.	Refer to Kit Guide for proper chip preparation.
<i>Probable causes</i>	<i>Solution</i>
Improper denaturation of ladder.	Use fresh ladder aliquot. Heat ladder for 5 minutes at 100°C. Use 0.5 mL tubes for denaturation.
Diluted ladder is too old.	Use diluted ladder within one day.
Pipetting error during preparation of reagent mixes.	Check dilution procedure and calibration of pipette.

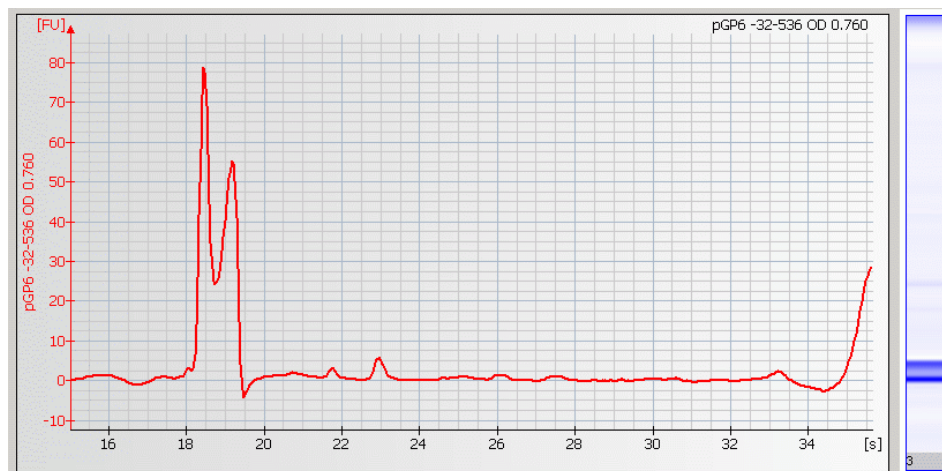
<i>Most probable causes</i>	<i>Solution</i>
Chip not properly primed. Clogged chip priming station or wrong priming station settings.	Prepare a new chip. Check chip priming station as described in “Checking the Chip Priming Station for Proper Performance - Seal Test” on page 134. Clean/replace gasket, syringe and plastic adapter, if necessary. Check if clip and base plate of priming station are in the correct position (see Kit Guide)
Protein chips expired.	Check expiration date on chip box.
Protein concentration in samples too high.	Use protein concentration according to specifications given in the Kit Guide.
<i>Least probable causes</i>	<i>Solution</i>
Defective heater plate.	Run the temperature test by using the “Overview” on page 27. If the heater plate is defective, contact Agilent Technologies at https://www.agilent.com/en/contact-us/page .

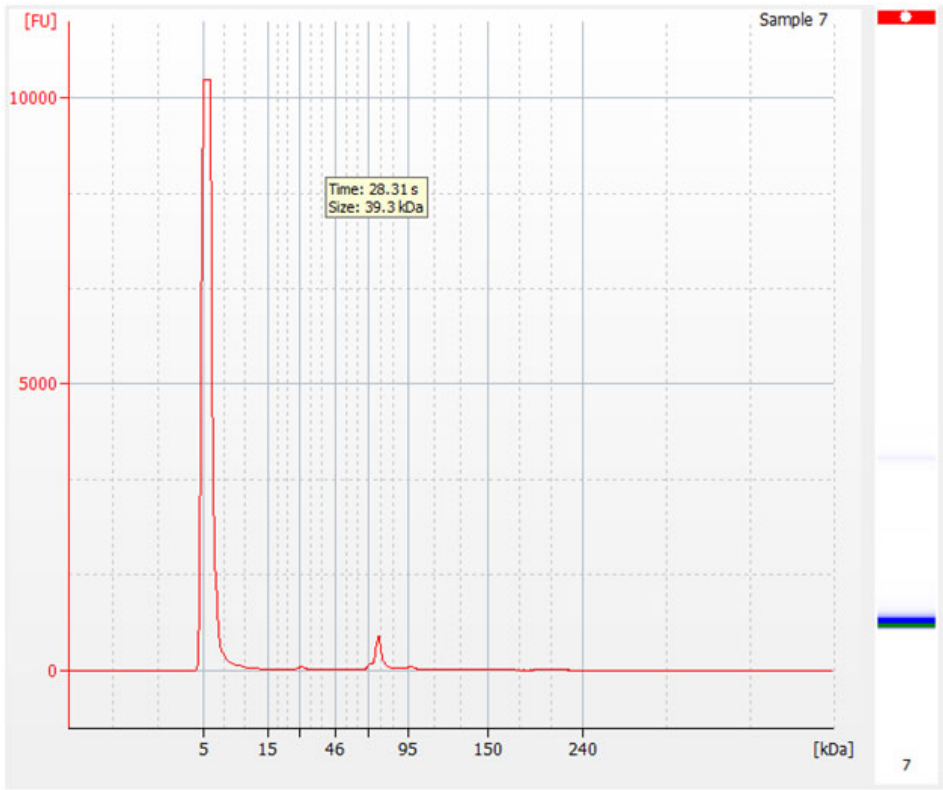
Code	Description	Category
1	✖	559	Optical signal too high (1605h)	Instrument

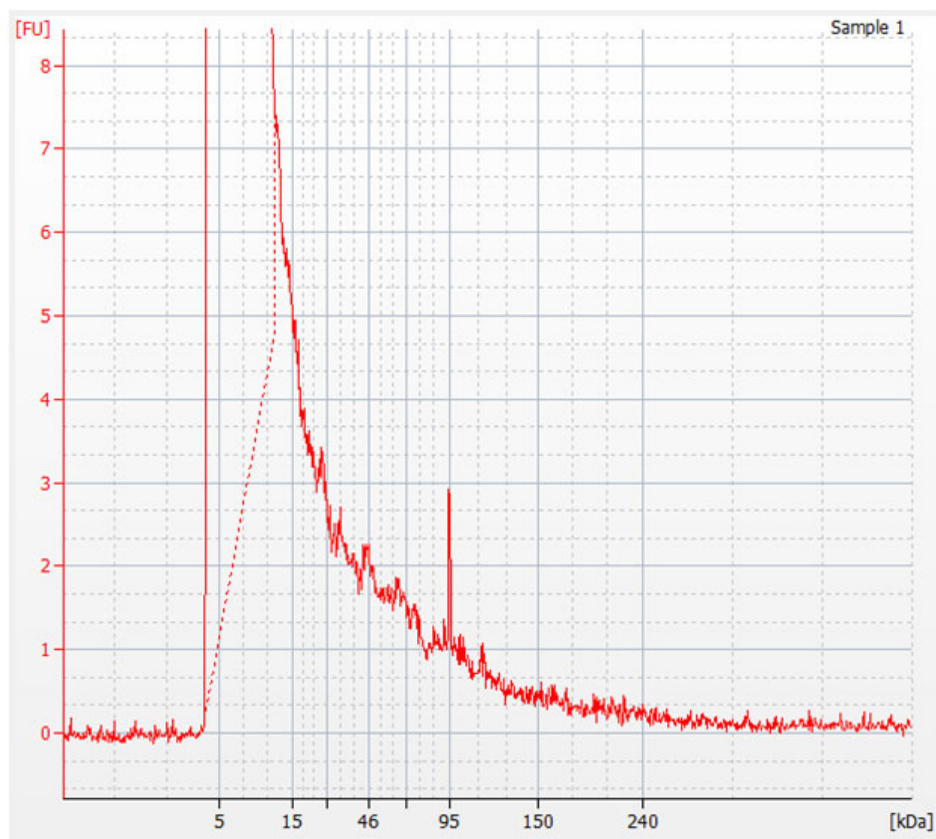
Most probable causes	Solution
Insufficient labeling of ladder or samples.	Follow instructions in the Kit Guide. Labeling occurs between pH 8-9. Proteins must contain lysines for labeling reaction. Check buffer compatibility in the "Compatibility List for the Labeling Reaction" in the Kit Guide.
Insufficient sample present.	Follow instructions for protein concentration in the Kit Guide. For details, see https://www.agilent.com/cs/library/technicaloverviews/public/5989-8940EN.pdf

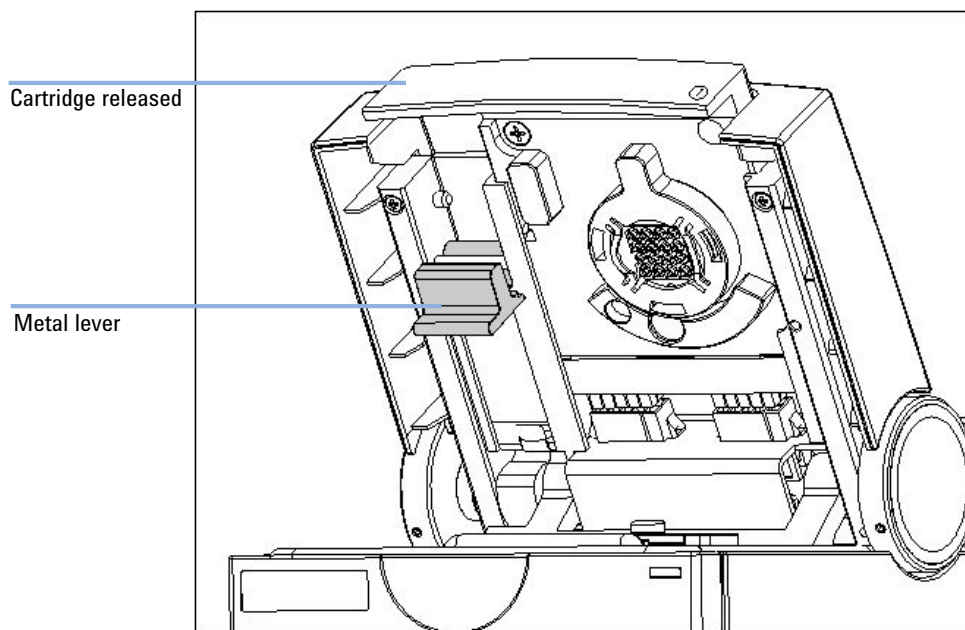
Figure 1 Remove/replace the electrode cartridge

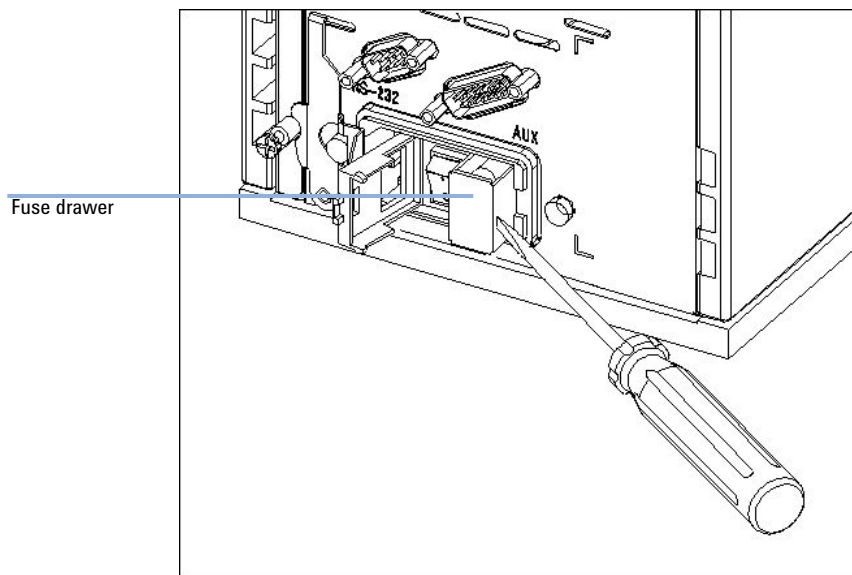
Figure 11 Remove fuse drawer
