## Description of correction for data dropout problem

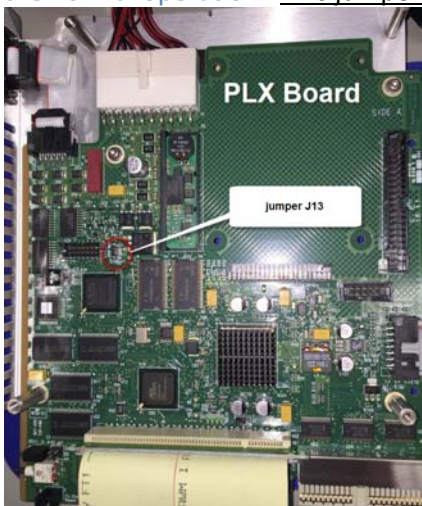
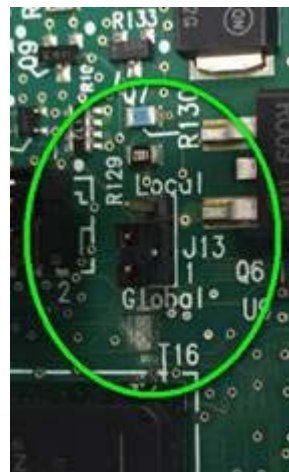
**Background Information:** The PLX board (pictured below) has a jumper J13 that needs to be set correctly for the FPGA uploader program to work correctly. That jumper is part of the JTAG chain. The only purpose of that JTAG chain is to program the FPGAs. There are 3 devices in this specific JTAG chain: FPGA on the PLX board, FPGA on the main board 1 and FPGA on the main board 2. In some cases, such as the simulator used by software developer, there is no main board, so the JTAG chain is broken. The jumper is a way to loop back the JTAG signal in absence of the main board. These jumps (include the ones on the main board) are only used when updating the FPGA bits. They have no effect on the normal operation. This jumper J13 on the PLX board has to be set to 'Global' position. See pictures below:
