Troubleshooting DFTPP Tuning Issues

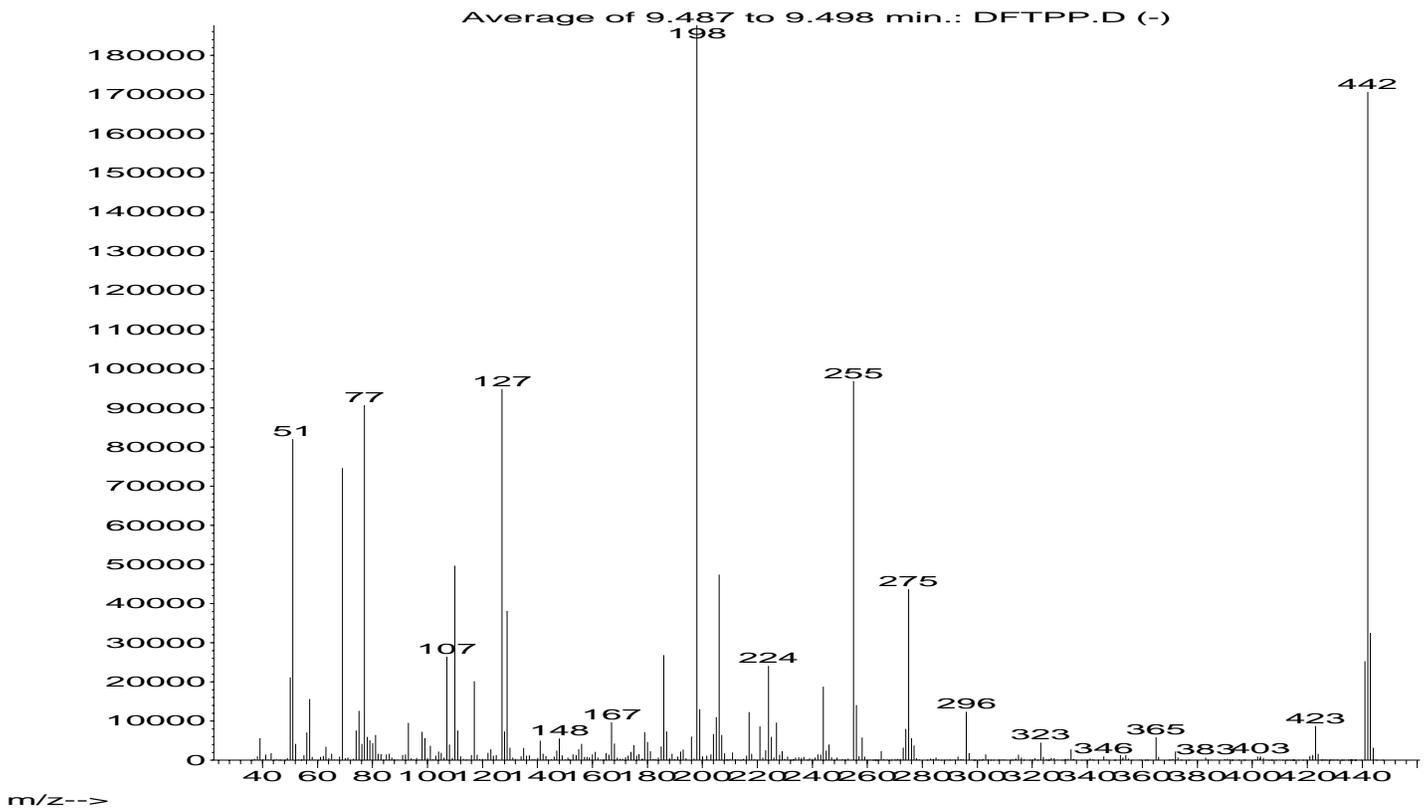
Notice the y-axis abundance for mass 198 on the order of 180,000 counts. If the same solution is used over time, the abundance of mass 198 may increase. This in turn can make the ratio of the 442 increase, resulting in the failure to pass the EPA criteria at the higher mass fragment. This can be due to the evaporation of the solvent, which in turn makes the concentration of the DFTPP higher than that originally prepared.

Prepare a new solution of DFTPP from a fresh stock standard. If this is the scenario, the abundance of the 198 should be more similar to the injection from the DFTPP that was performed after the last tuning was done.
