# Composite thermal damage – correlation of short beam shear data with FTIR spectroscopy

Portable, non-destructive analysis

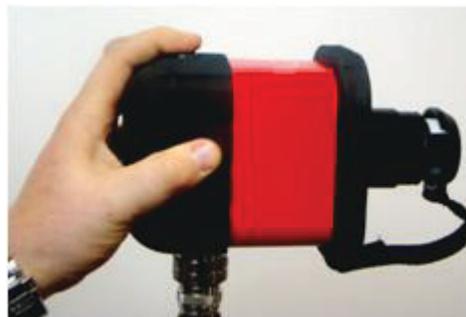
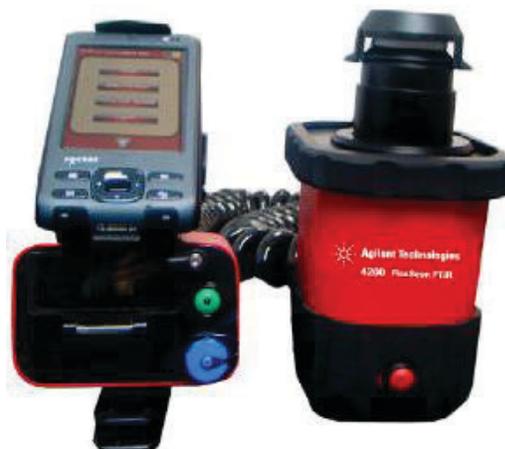
[www.agilent.com/chem](http://www.agilent.com/chem)
