Component failure analysis of vehicle spark plugs using FTIR spectroscopy with a micro-ATR large sample objective

Application note

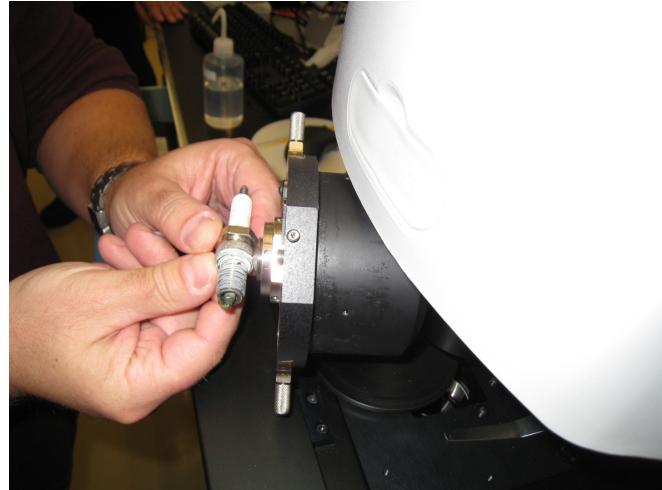
† Mississauga, ON, Canada
