Agilent Technologies

Quick Reference Guide
for
Troubleshooting 7683 Autosampler Errors

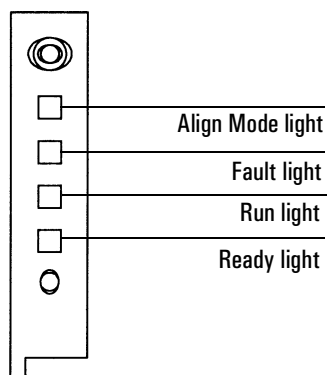
Figure 16 Injector status lights

Four lights on the injector indicate its status.

During normal operation, the Ready light is on. If the injector is busy, the Run light is on.

If another combination of lights are on, an error has occurred.
