Agilent 700 Series ICP-OES Maintenance Tips & Tricks

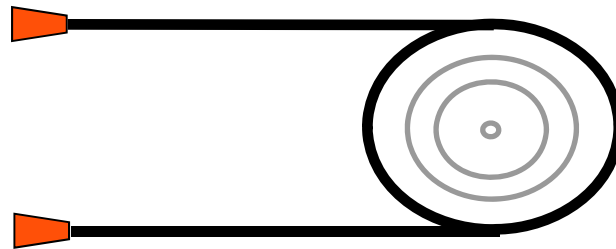
Torch Alignment (1)

Must be Concentric within Coil

- Uneven RF can cause Torch Meltdown
- Arcing between Plasma & Coil

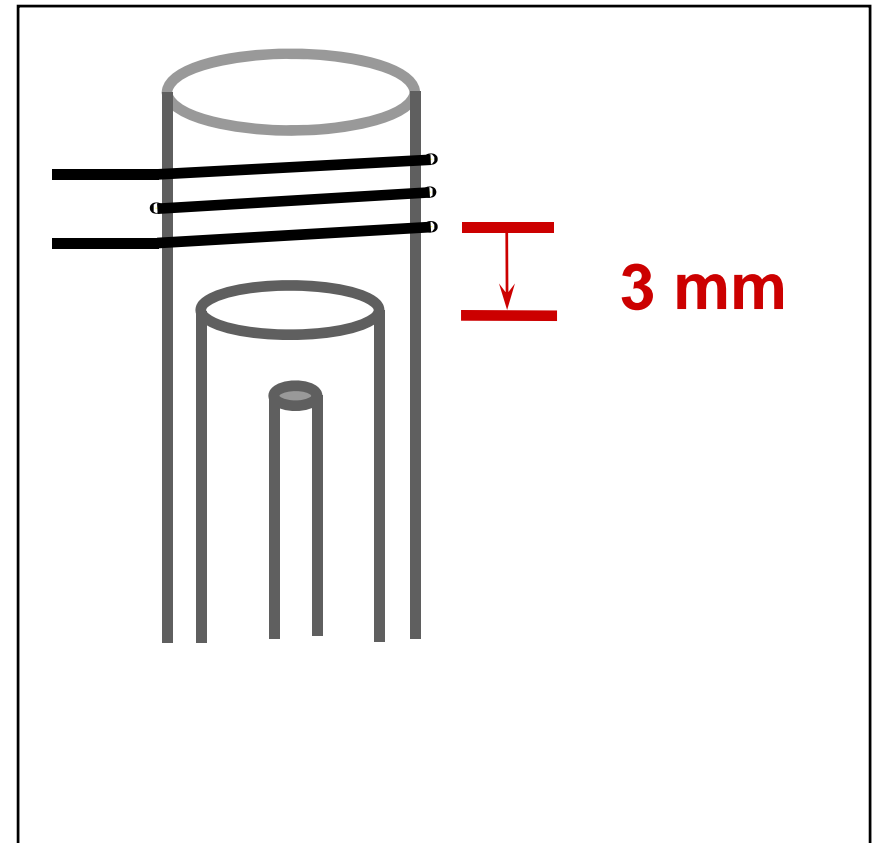
Replacing Radial Torch

Position the top of the torch intermediate tube at least 2 mm below the induction coil

- Arcing may occur if too low
- Torch Meltdown or Plasma Ignition Failure if too high

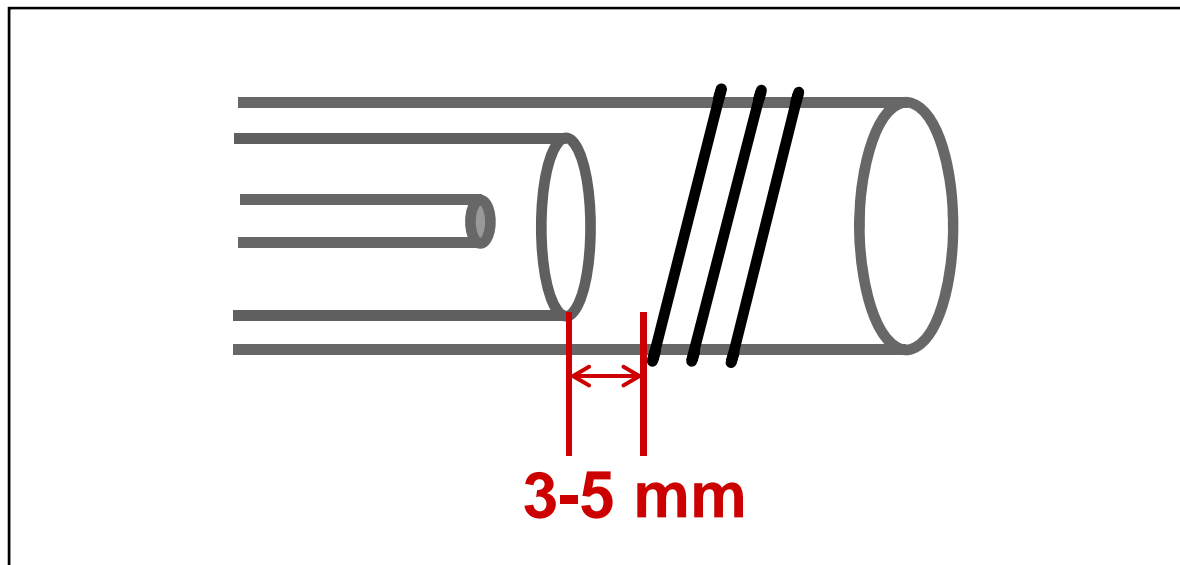
Replacing Axial Torch

Align the torch horizontally by positioning it so that the intermediate tube of the torch is approximately 3 mm to the left of the left end of the induction coil

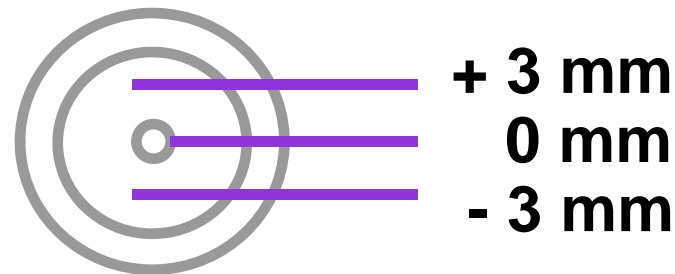
Top View of Torch

Horizontal Torch Alignment (4)

Perform after **Radial** or **Axial** torch removal/replacement

- +/- 1.5 mm from center
- Go to Torch Alignment page in Instrument Module
- Select TORCH method provided with the software
- Use the provided tuning solution (1:10)
- Method scans for Mn at 257.610 nm

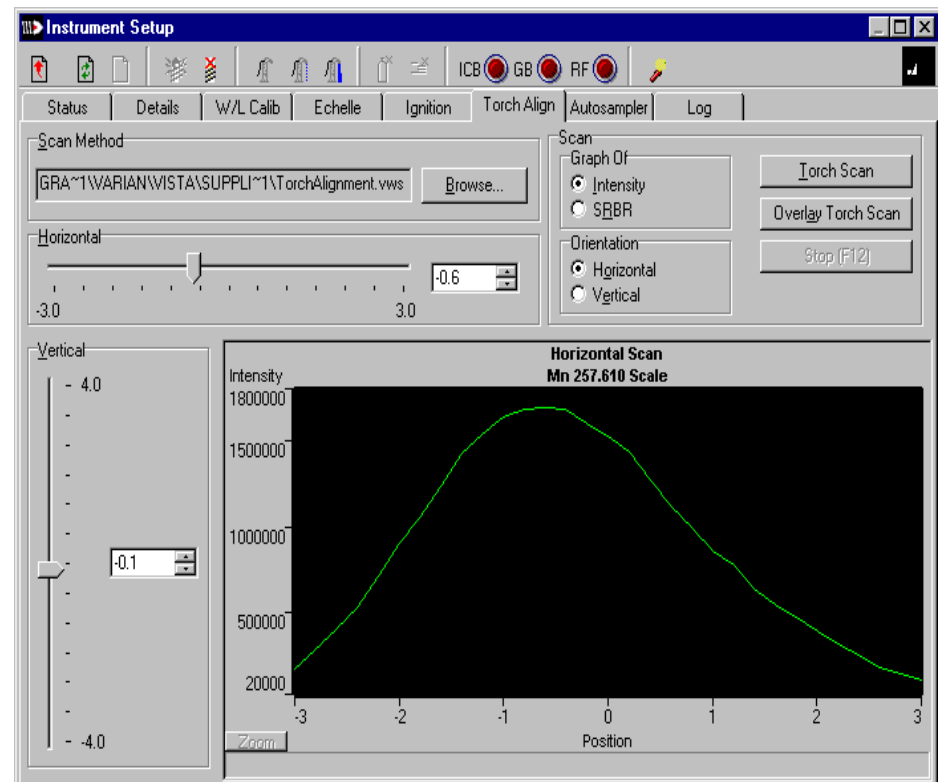
Troubleshooting (4)

It's a good idea to keep a log of the intensities whenever you run the Torch Alignment program
