Release Notes

Agilent Microarray Scanner Software Versions A.8.3

for Agilent G2565CA Microarray Scanner

This document describes the enhancements, defect fixes, and software compatibility issues related to the release of Scan Control V 8.3.

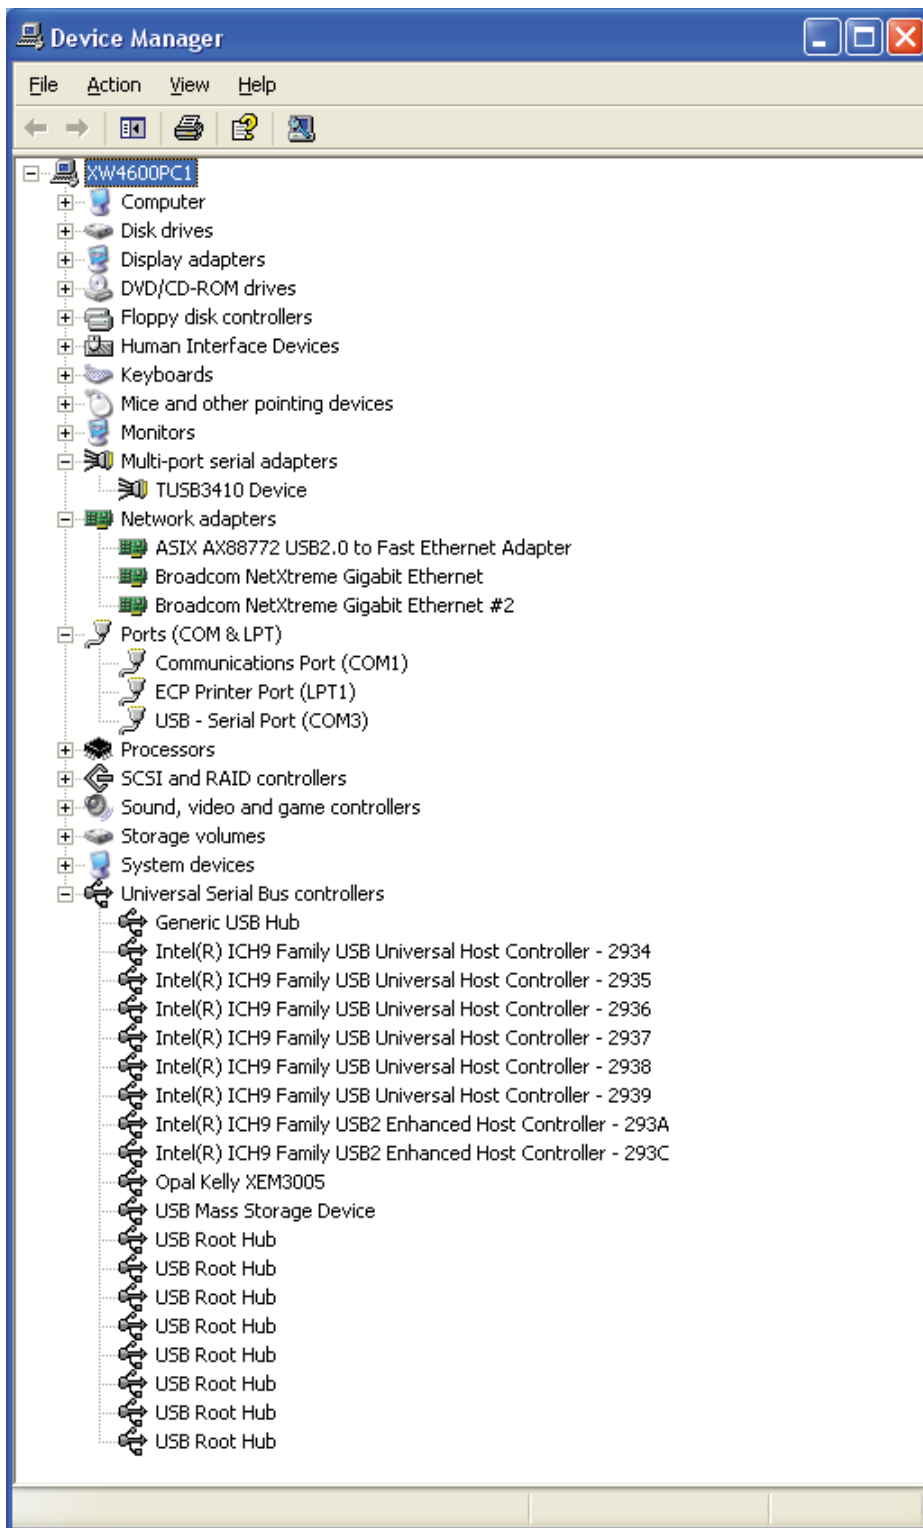
When operating correctly, these connections can all be seen in the Device Manager, as shown below. The hub is visible as "Generic USB Hub"; the data collection system can be seen as "Opal Kelly XEM3005"; the Ethernet as "ASIX AX88772" Ethernet adapter; and the serial as "USB - Serial Port (COM3)".

Use of a high-quality USB2 cable is required for correct operation of the scanner. Using a USB1 cable, or a cable with a ferrite, may result in failure to connect, or loss of data.
