Cleaning the HED

5973A/N MSD

Purpose:

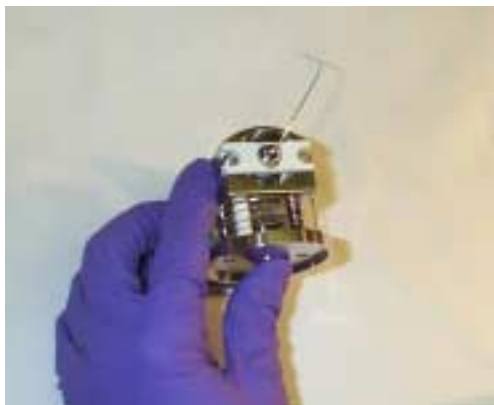
3. Find the long high voltage wire that protrudes from the top of the HED. This wire connects to a ceramic plate on top of the HED that is held in place with two M2 hex head screws.

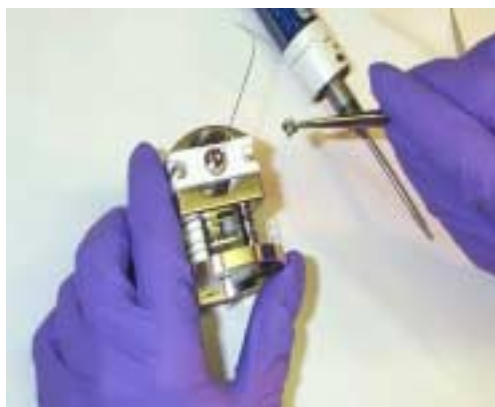
4. Using a hex head Allen wrench or driver (not a Torx driver) carefully remove both screws and set them aside.

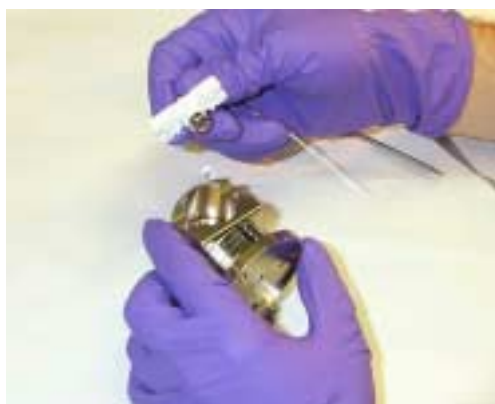
5. Remove the ceramic assembly from the top of the HED and notice the stainless steel button at the bottom of the assembly. This is the part that is going to be cleaned.

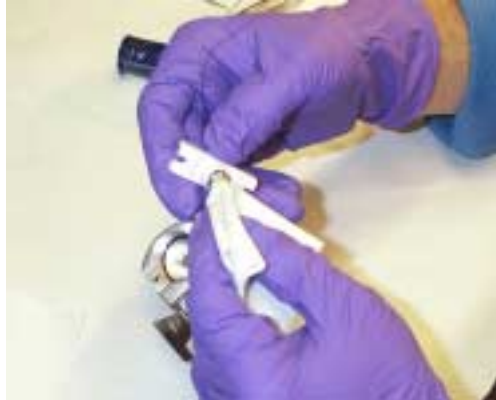
6. Using a lint-free cloth and isopropyl alcohol, wipe off the button. Blow off the button with nitrogen to dry it and remove any lint that your “lint-free” cloth may have left behind.

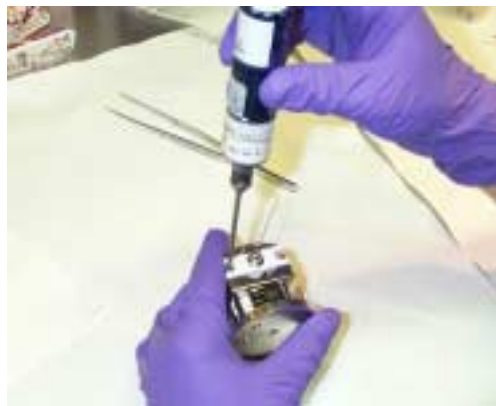
7. Reassemble the ceramic top on the HED and tighten the hex head screws.

8. Carefully inspect the HED to make sure that the ceramic piece did not crack when you tightened the screws down. Reconnect any wires that you may have disconnected.
